HAZARDOUS MATERIALS ASSESSMENT

Basin Head Museum & Cannery

336 Basin Head Rd, Souris, PE

March 9, 2023

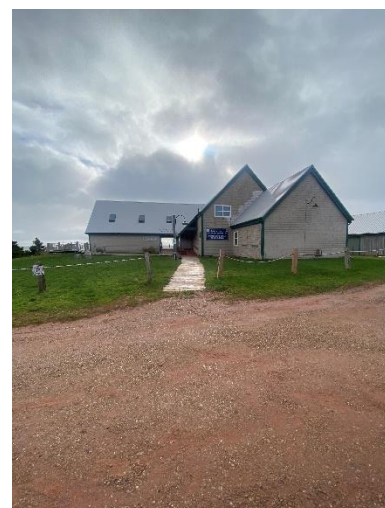
Museum

A total of eight (8) bulk material samples were collected within the museum building during the survey. Some of these samples such as drywall and joint compounds were separated and a total of thirteen (13) samples were analyzed. Of the 13 samples analyzed, two (2) were found to be asbestos containing.

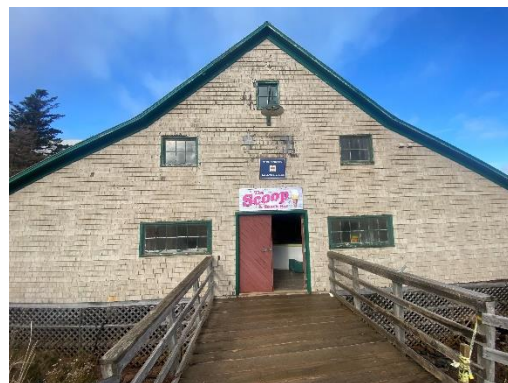
Cannery & Apartment

A total of six (6) bulk material samples were collected within the cannery and apartment building during the survey. Some of these samples such as drywall and joint compounds were separated and a total of eight (8) samples were analyzed. Of the 8 samples analyzed, none were found to be asbestos containing.

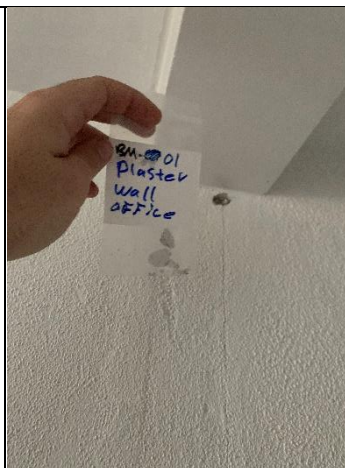
4.1.1 Texture Coat Finishes

Texture coat finish was observed in the museum building. The material was sampled and reported with no asbestos detected.

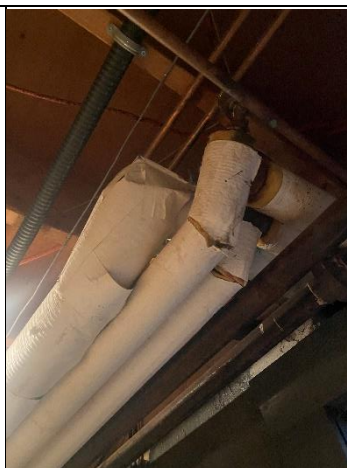
4.1.2 Pipe Insulation

Straight sections and the elbows of pipe are insulated with fiberglass.

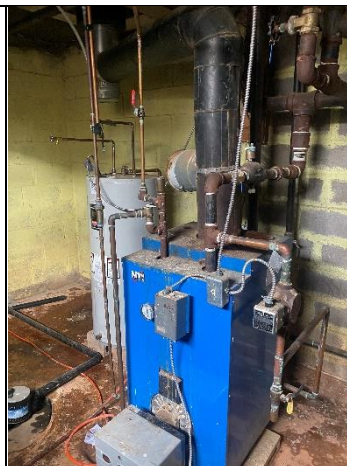
Newer mechanical boiler visually identified with metal cladding with fiberglass insulation liner.

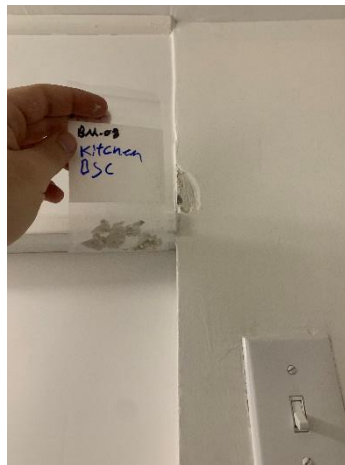
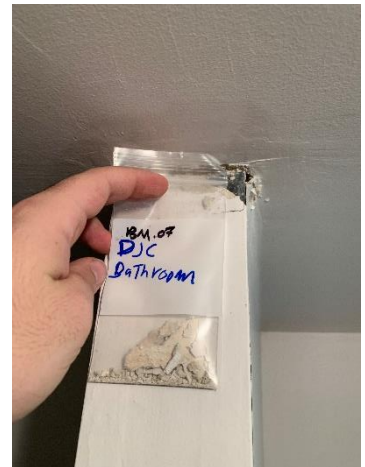
4.1.6 Drywall Joint Compound

Drywall joint compound walls and ceilings were noted and sampled in various random locations throughout the buildings.

A total of eight (8) joint compound samples were collected during the assessment. Two samples sampled on the main floor were found to contain **1.5% -1.9% Chrysotile** asbestos. Three joint compound samples collected in the basement were all reported as non asbestos containing.

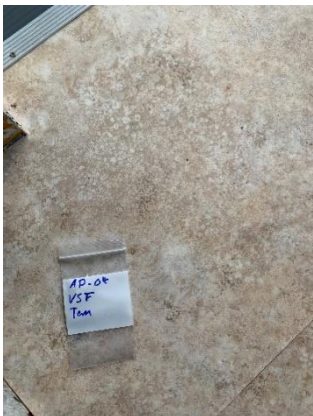
Sample No.:	Flooring Description	Location	Asbestos Type / Content (%)	Photo
AP-04	Tan colour vinyl sheet flooring	Apartment	None Detected

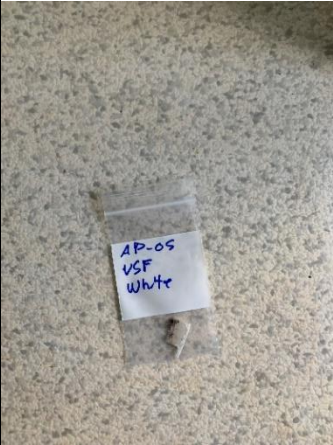
AP-05	White colour vinyl sheet flooring	Apartment	None Detected

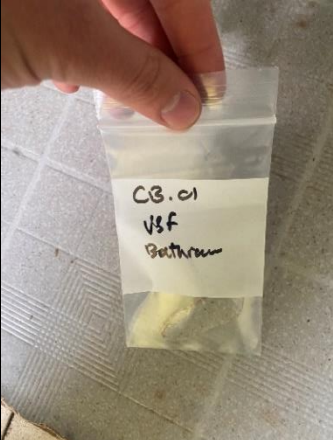
CB-01	Grey Vinyl sheet flooring	Cannery building – bathroom	None Detected

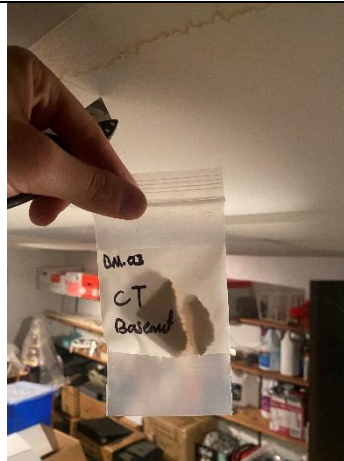
Only one area was noted with acoustic ceiling tiles in the museum basement. The material was sampled and reported with no asbestos detected.

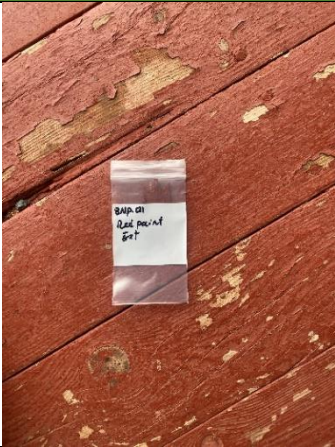
Sample No.:	Colour / Substrate Description	Location	Lead Content (%)	Photo
Museum				
BMP-01	Red paint	Exterior	< 0.0075

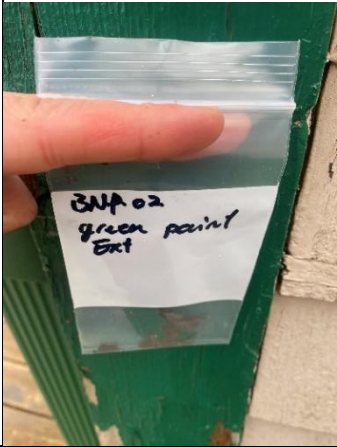
BMP -02	Green paint	Exterior	< 0.0061

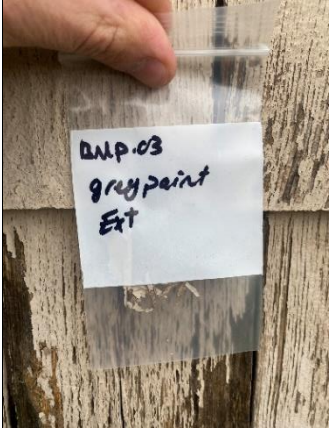
BMP -03	Tan paint	Exterior	< 0.0078

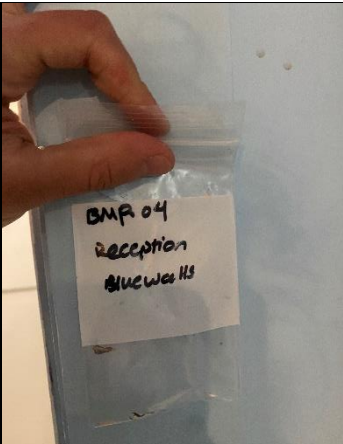
BMP -04	Blue wall paint	Reception area	< 0.0016

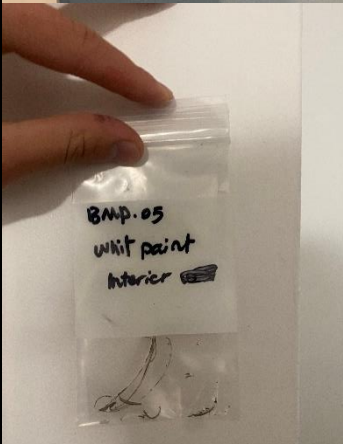
BMP -05	White paint	wall	0.020

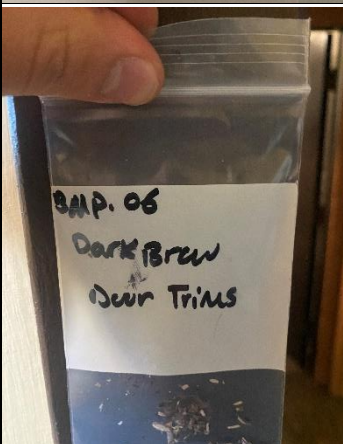
BMP -06	Brown paint	Door trims	< 0.0083

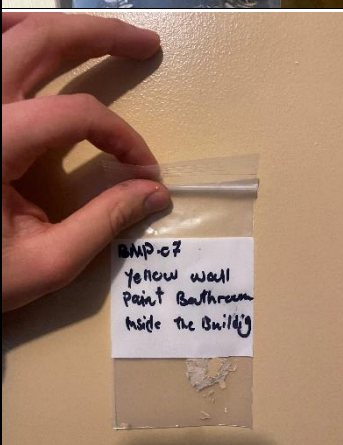
BMP -07	Yellow wall paint	Bathroom in the building	< 0.0063

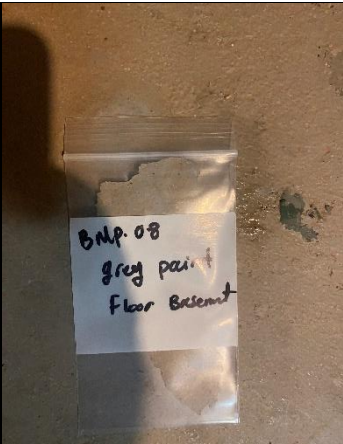
BMP -08	Tan floor paint	Basement	< 0.0066

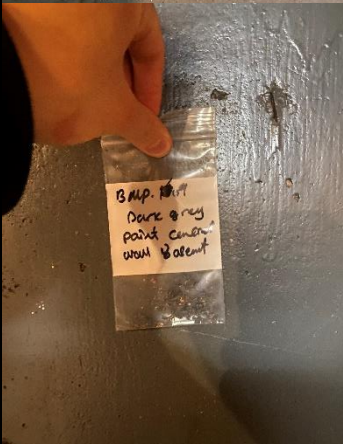
BMP -09	Dark grey wall paint	Basement	< 0.0060

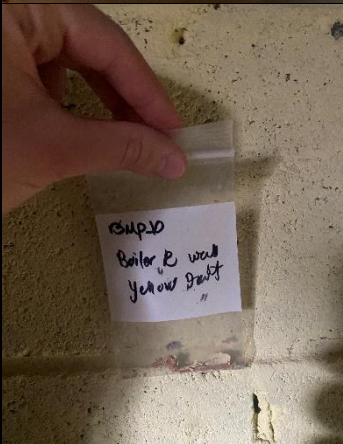
BMP -10	Yellow wall paint	Boiler room	< 0.011

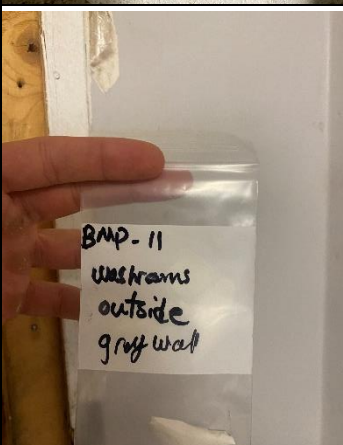
BMP-11	Grey wall paint	Outside washroom	< 0.0074

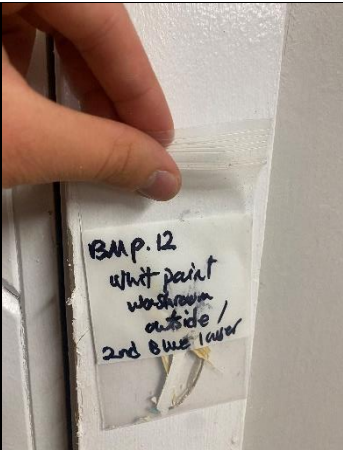
BMP-12	White with blue exterior paint	Outside washroom	< 0.0057

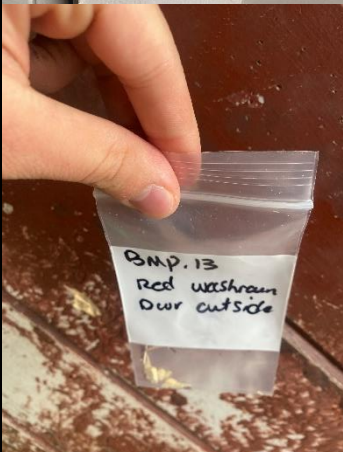
BMP-13	Red door paint	Outside washroom	< 0.0075

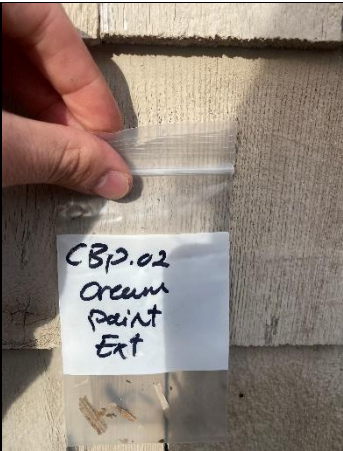
CBP-02	Cream paint	Exterior	0.0070

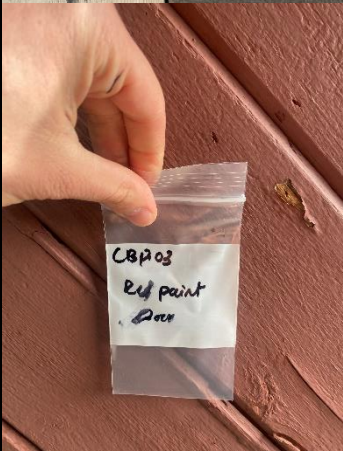
CBP-03	Red paint	Exterior	< 0.0079

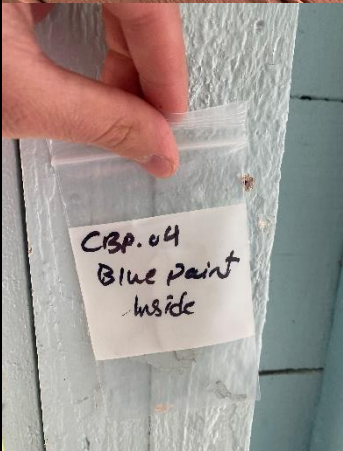
CBP-04	Blue paint	Inside	< 0.0063

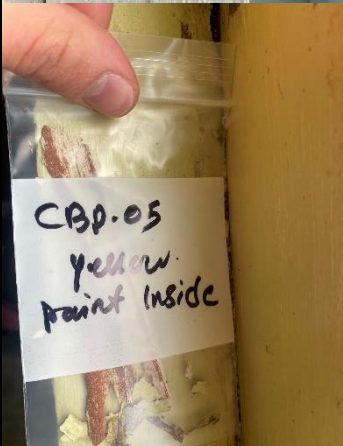
CBP-05	Yellow paint	Inside	0.0081

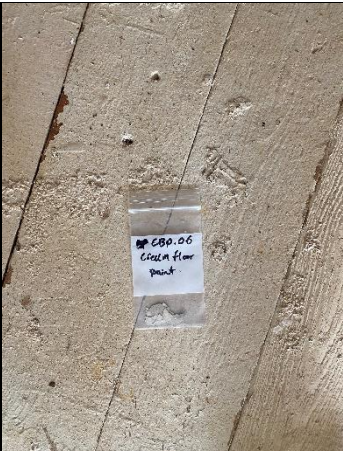
CBP-06	Cream paint	Floor	< 0.0073

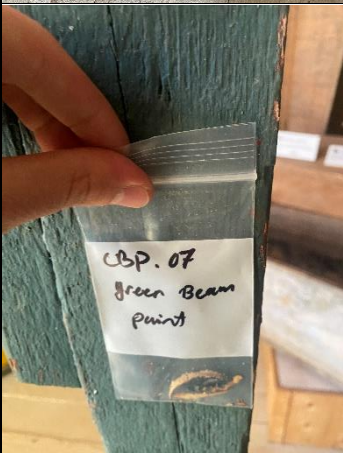
CBP-07	Green paint	Beam	0.93

Dispose of painted materials exceeding the criteria for leachable lead as hazardous waste.

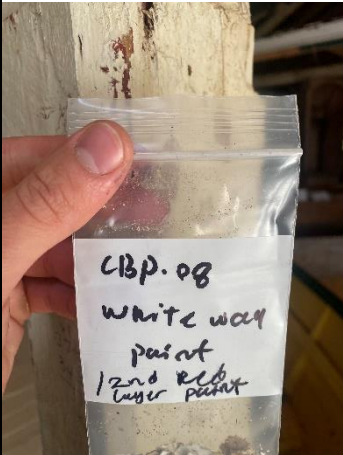
CBP-08	1 st layer with paint/ 2 nd layer red paint	Wall	0.18

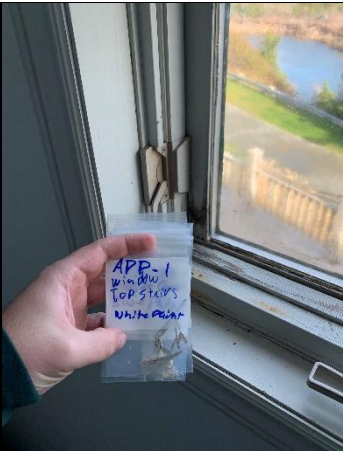
APP-01	White paint	Window at the top of the stairs inside	< 0.0092

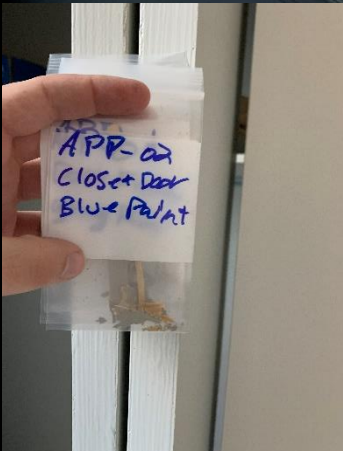
APP-02	Blue paint	Closet door inside	< 0.0085

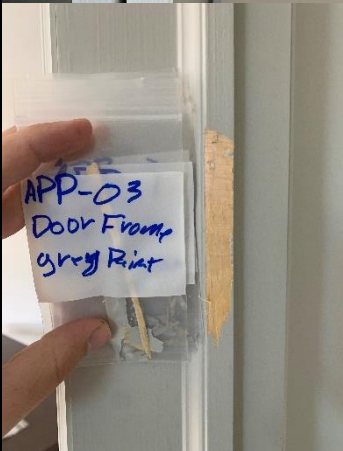
APP-03	Grey paint	Door frame inside	< 0.0079

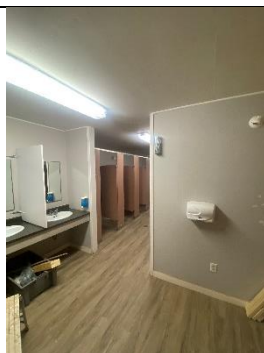
Photo 1

Newer recessed light fixtures were observed in the museum building. Other lights present were non ballast containing. Typical lights and ballasts found and reported are noted below in section 4.3.1. Manufacturer's labels were marked as non-PCB containing.

Through referencing and markings on lamp ballasts, it was determined that the ballasts observed on site are non-PCB containing.

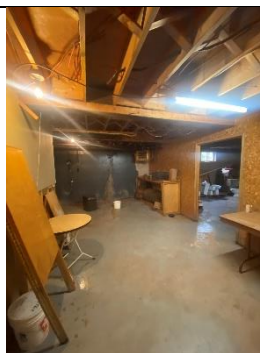
Photo 2 – Basement fluorescent light fixtures. No PCB's.

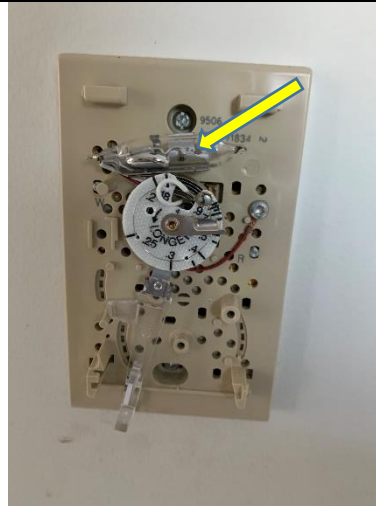
4.4.2 Mercury Containing Devices

Mercury containing thermostats ampules were reported in the apartment.

Do not break lamps or separate liquid mercury from components. Recycle and reclaim mercury from fluorescent lamps and thermostats when taken out of service. Mercury is classified as a hazardous waste and must be disposed of in accordance with applicable regulations.

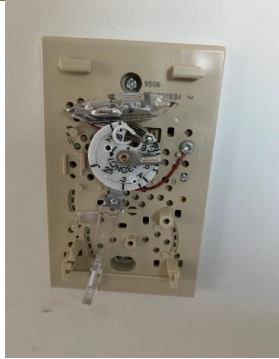
Room No.	Location	Sample No.	Material	Comments	Photo
NA	Apartment	NA	Thermostat
