HAZARDOUS MATERIALS ASSESSMENT

Hon. George Coles Building

175 Richmond Street,

May 3, 2023

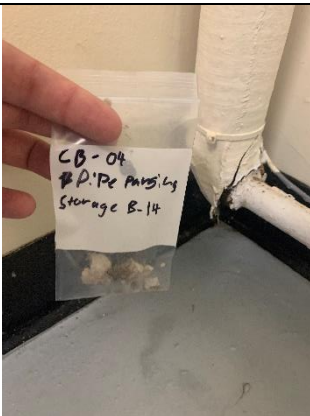
<p>Photo 1</p>

<p>Pipe fittings in the accessible areas in the basement were noted with parging cement or fiberglass. Representative samples were collected, and none were found to be asbestos containing. Additional inspections of pipe fittings of like materials were reported as the same.</p> <p>Straight sections of pipe are insulated with fiberglass (photo 2 & 3).</p>

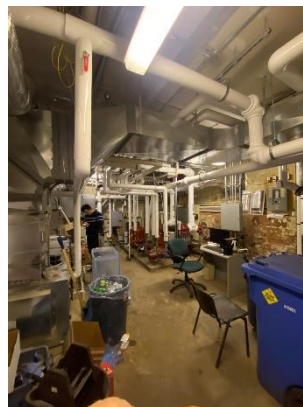
New mechanical heating system in place. Fibreglass insulation under PVC pipe. No suspect ACMs observed or tested.

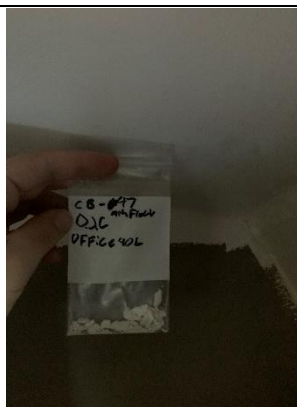
Drywall joint compound walls and ceilings were noted and sampled in various random locations throughout the building.

A total of thirty-six (36) joint compound samples were collected during the assessment. None of the samples were found to be asbestos containing.

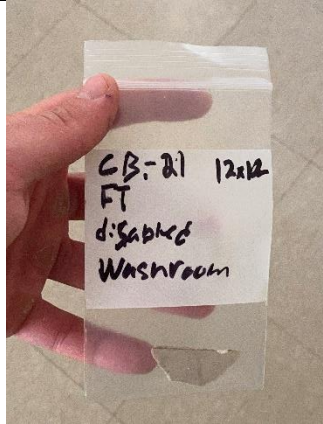
Sample No.:	Flooring Description	Location	Asbestos Type / Content (%)	Photo
CB-21	12" x 12" off-white vinyl floor tile with tan mastic	1 ST Floor washroom	None Detected in flooring or mastic

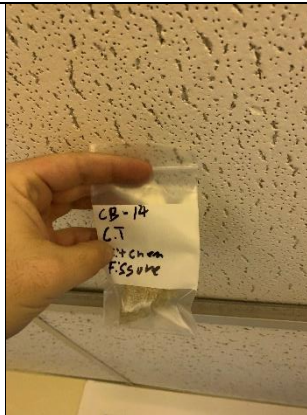
Photo 1

Fissure design (photo 1) and pinhole design (photo 2) ceiling tiles as well as fine fissure new design (photo 3) were observed, and random representative sampling was completed for each type of tiles encountered throughout the building.

A total of ten (10) ceiling tiles were collected during the assessment. None of the samples were found to contain asbestos.

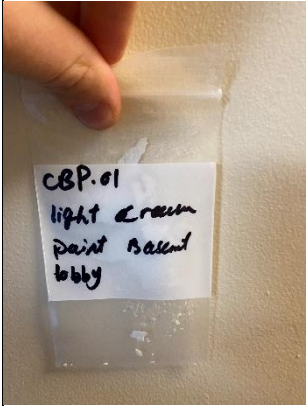
Sample No.:	Colour / Substrate Description	Location	Lead Content (%)	Photo
CBP-01	Light Cream paint / Wall surface	Basement Lobby	< 0.0068

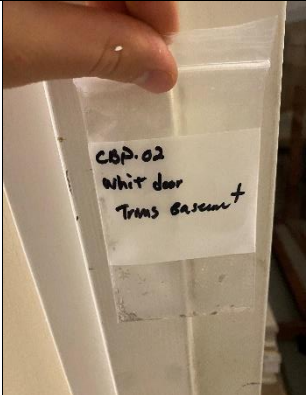
CBP-02	White paint / Door trim	Basement	0.030

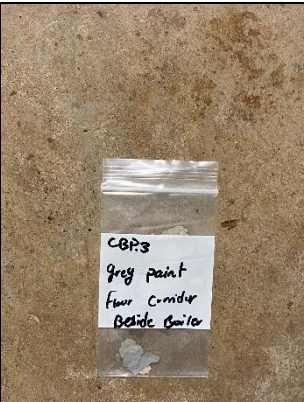
CBP-03	Grey paint / Concrete floor	Basement Boiler room	0.0067

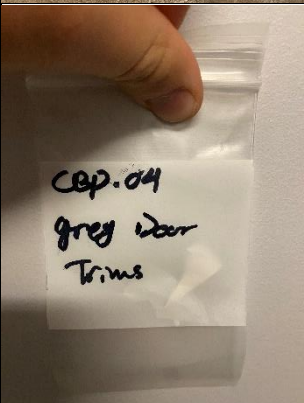
CBP-04	Grey paint / Door trim	Basement	< 0.0073

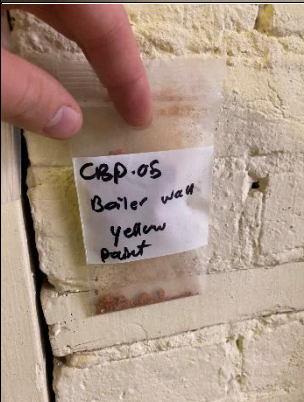
CBP-05	Yellow paint / Wall surface	Basement Boiler room	< 0.0077

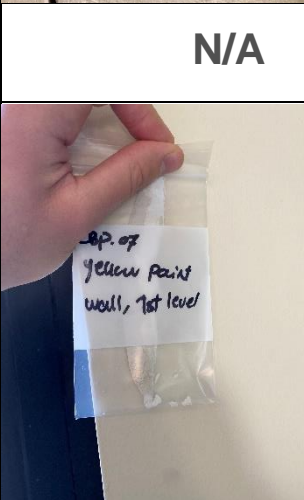
CBP-06	Yellow paint / Tunnel concrete	Basement Tunnel	0.022	N/A	
CBP-07	Yellow paint / Wall surface	1 st Level	< 0.0048

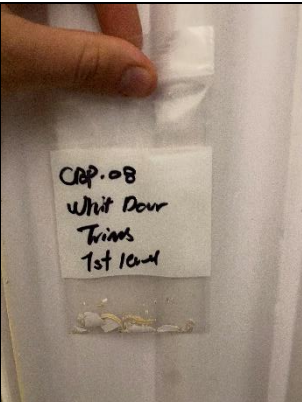
Based on the assessment findings, two (2) of the paint layers sampled exceeded CEPA guidelines of 0.06 percent by weight for surface coating materials. Exceedances are noted in bold red in the table below.

CBP-08	White paint / Door Trim	1 st Level	0.24

Dispose of painted materials exceeding the criteria for leachable lead as hazardous waste.

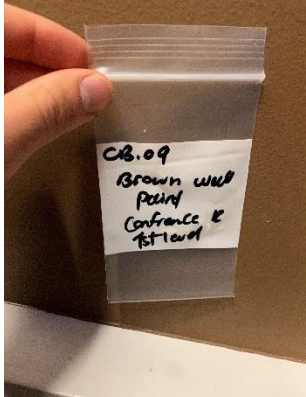
CBP-09	Brown paint / Wall	1 st Level Conference Room	0.015

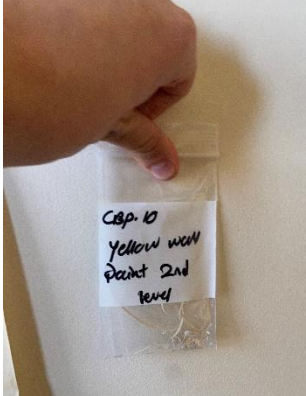
CBP-10	Yellow paint / Wall surface	2 nd Level	< 0.0071

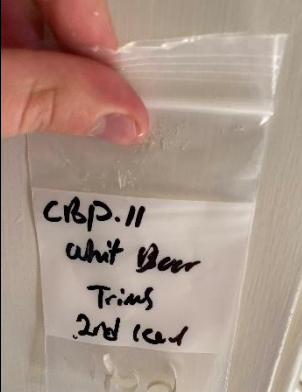
CBP-11	White paint / Door trim	2 nd Level	0.086

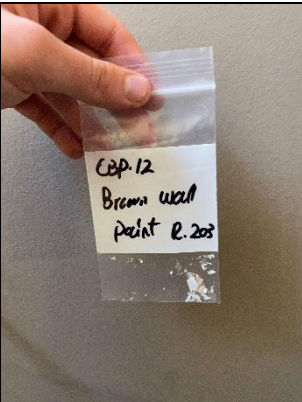
CBP-12	Brown paint / Wall surface	Room 203	< 0.0087

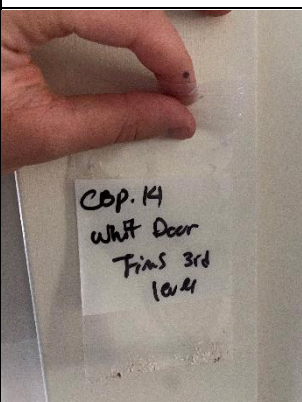
CBP-13	Yellow paint / Wall surface	3 rd Level	< 0.0077	N/A	
CBP-14	White paint / Door trim	3 rd Level	Void

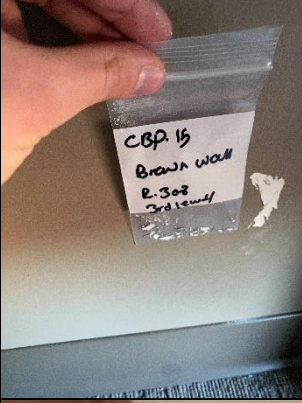
CBP-15	Brown paint / Wall surface	3 rd Level / Room 303	< 0.0094

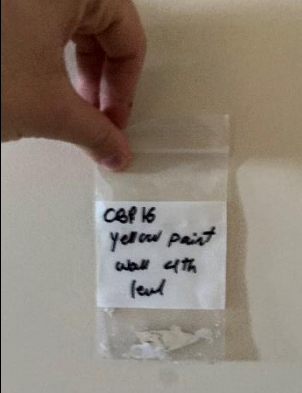
CBP-16	Yellow paint / Wall surface	4 th level	< 0.0074

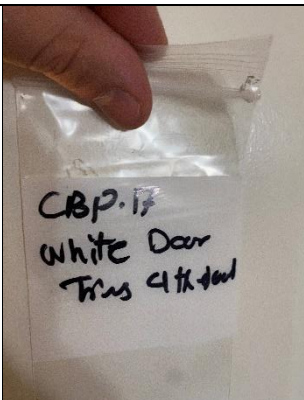
CBP-17	White paint / Door trim	4 th Level	Void

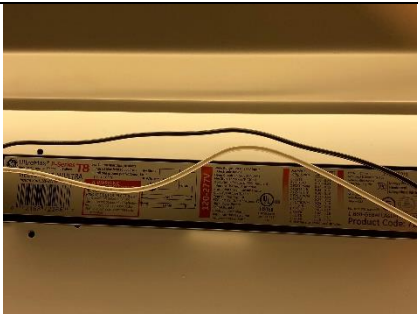
Photo 1
--	--

Photo 1 – GE Ultra Max Lamp Ballasts with manufacturers label as “No PCB's”.
