HAZARDOUS MATERIALS ASSESSMENT

Customs House Building

40 Great George Street, Charlottetown, PE

ALL-TECH Project No.: PE22400

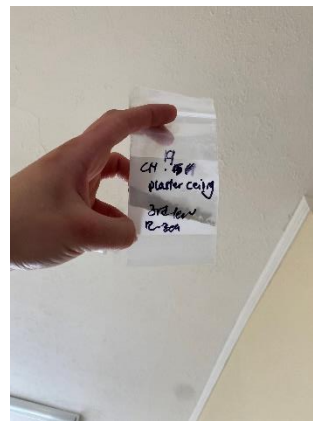
Texture coat finish plaster ceiling observed and sampled on 3rd floor (sample CH-19 – non asbestos containing).

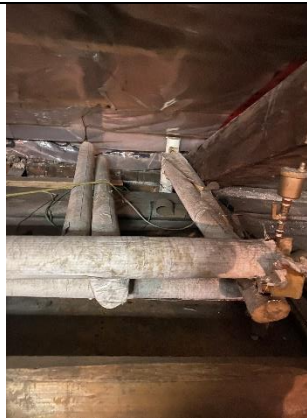
Photo 1

Straight sections of pipe insulations were various. Some were visibly identified as fiberglass (photo 1). Other pipes were brown hair insulation which was tested and analyzed as non-asbestos containing (photo 2).

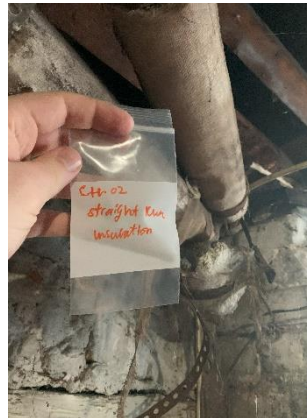
Photo 3

There were limited areas noted and sampled of aircell pipe insulation which was found to contain **25% Chrysotile Asbestos** (photo 3).

Asbestos containing aircell straight run pipe insulation was noted in a limited area in the basement area and was noted in poor condition and has been identified in the Summary of ACM conditions and action report in Appendix IV and shall require action to bring conditions to acceptable conditions. Additional floor plans have been added in Appendix III to assist in locating these areas.

Room No.	Description	Sample No.	Material description	Asbestos Type & Content (%)	Estimated Volume or Area	Friable (F) Non-friable (NF)	Access	Condition	Action Code (refer to legend)	Photo
B1		CH-02	Stright run pipe insulation (aircell)	Chrysotile 25%	4.5 m	F	B	poor	2

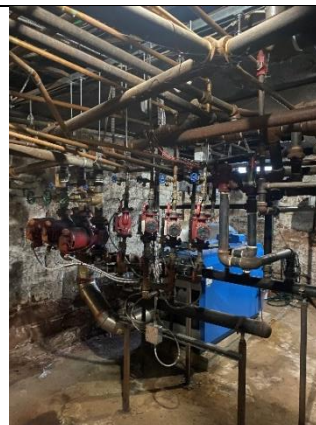
Newer boiler system in place. No suspect mechanical equipment insulations were observed or reported.

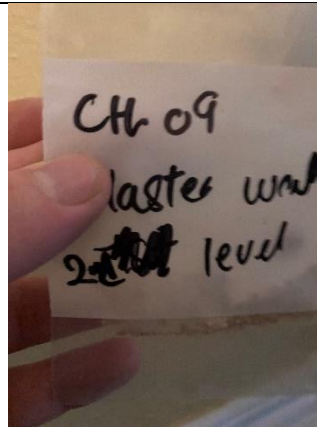
A total of fourteen (14) plaster samples were collected with both the white scratch coat and underlying base coats analyzed. None of the samples were found to be asbestos containing.

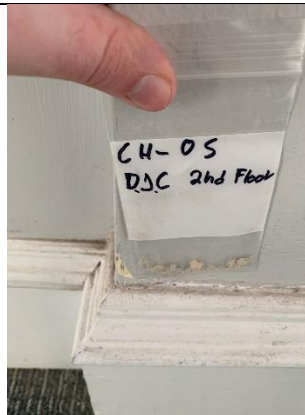
A total of seven (7) joint compound samples were collected during the assessment. One of the samples was found to contain **1.9% Chrysotile Asbestos**.

Room No.	Description	Sample No.	Material description	Asbestos Type & Content (%)	Estimated Volume or Area	Friable (F) Non-friable (NF)	Access	Condition	Action Code (refer to legend)	Photo
203	office	CH-05	Drywall joint compound	Chrysotile 1.9%		F	A	good	5

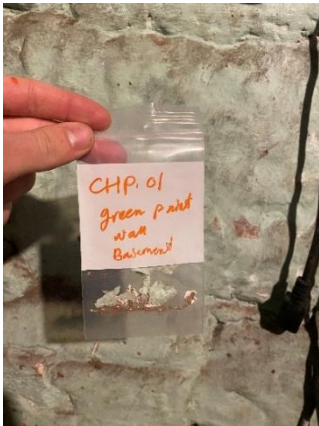
Sample No.:	Colour / Substrate Description	Location	Lead Content (%)	Photo
CHP-01	Green paint / Wall surface	Basement	< 0.0054

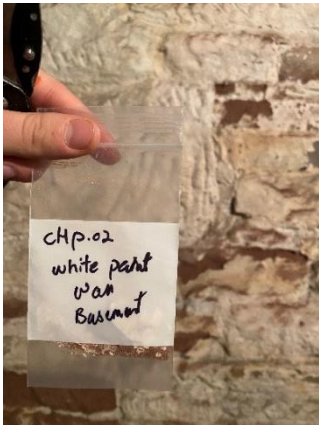
CHP-02	White paint / Wall surface	Basement	<0.0073

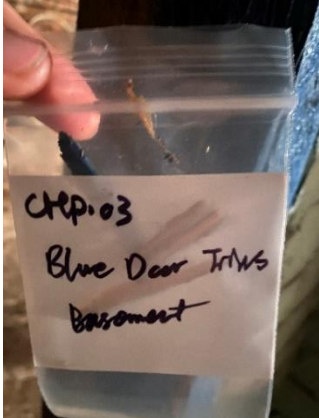
CHP-03	Blue paint / Door trims	Basement	0.25

Dispose of painted materials exceeding the criteria for leachable lead as hazardous waste.

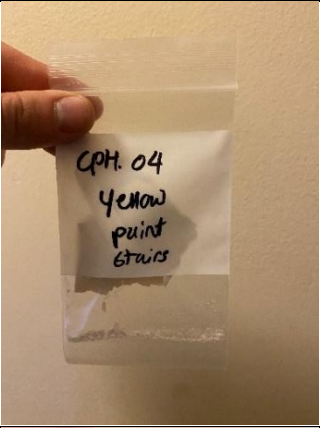
CHP-04	Yellow paint / Wall surface	Stairwell	< 0.0073

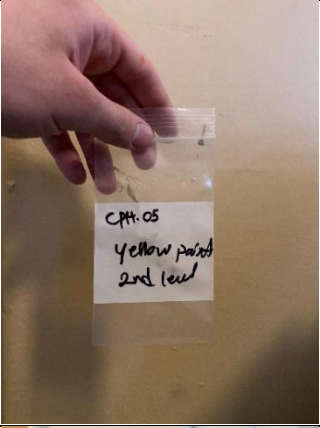
CHP-05	Yellow paint / Wall surface	2 nd level	0.011

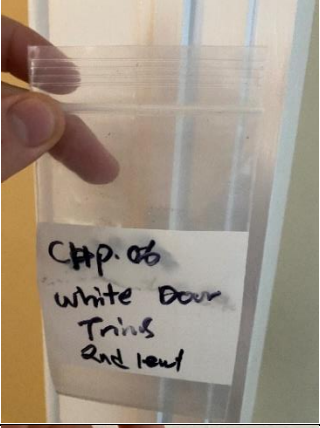
CHP-06	White paint / Door trims	2 nd level	7.1

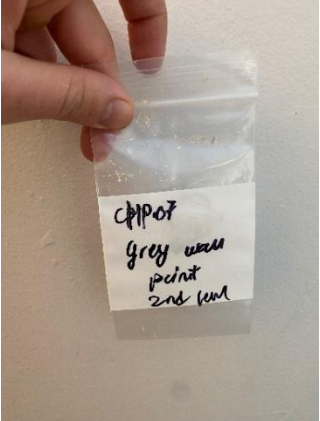
CHP-07	Grey paint / Wall surface	2 nd level	0.029

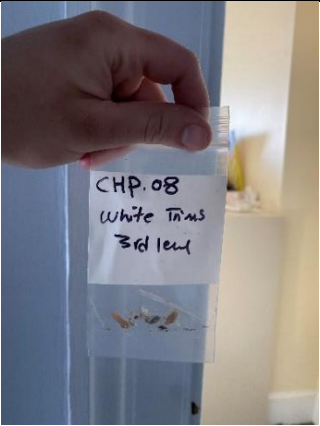
CHP-08	White paint / Trims	3 rd level	6.7

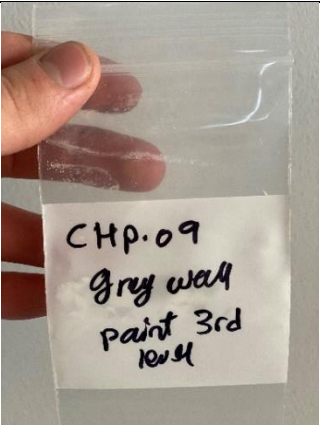
CHP-09	Grey paint / Wall surface	3 rd level	0.0078

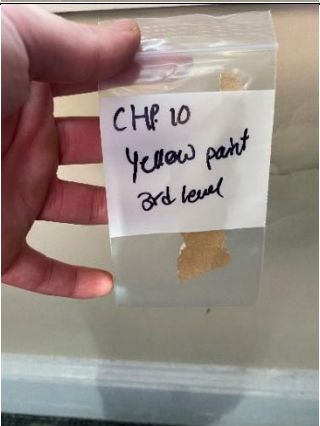
CHP-10	Yellow paint / Wall surface	3 rd level	5.5

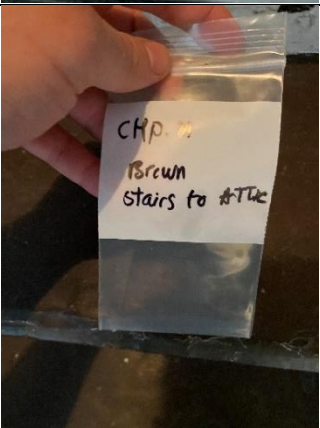
CHP-11	Brown paint / Wood stairs	Stairs to attic	0.093

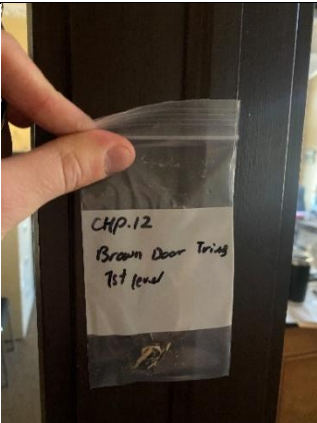
CHP-12	Brown paint / Door trims	1 st level	<0.0073

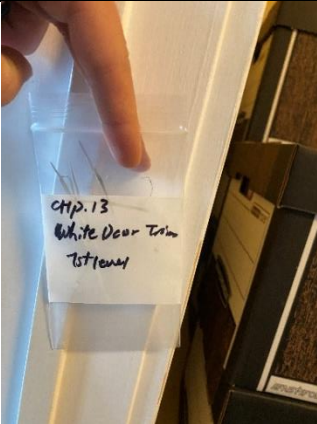
CHP-13	White paint / Door trims	1 st level	<0.011

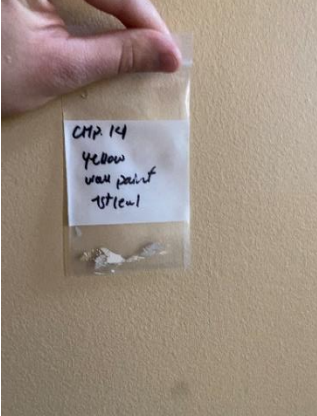
CHP-14	Yellow paint / Wall surface	1 st level	0.034

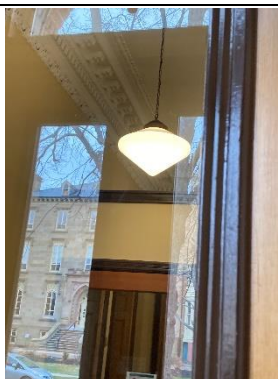
Incandescent lighting noted within the building and do not contain ballasts.

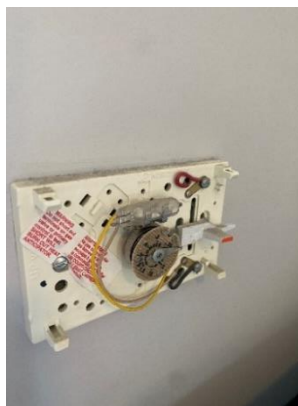
Photo 1

Mercury containing thermostats present (photo 1).

Do not break lamps or separate liquid mercury from components. Recycle and reclaim mercury from fluorescent lamps and thermostats when taken out of service. Mercury is classified as a hazardous waste and must be disposed of in accordance with applicable regulations.

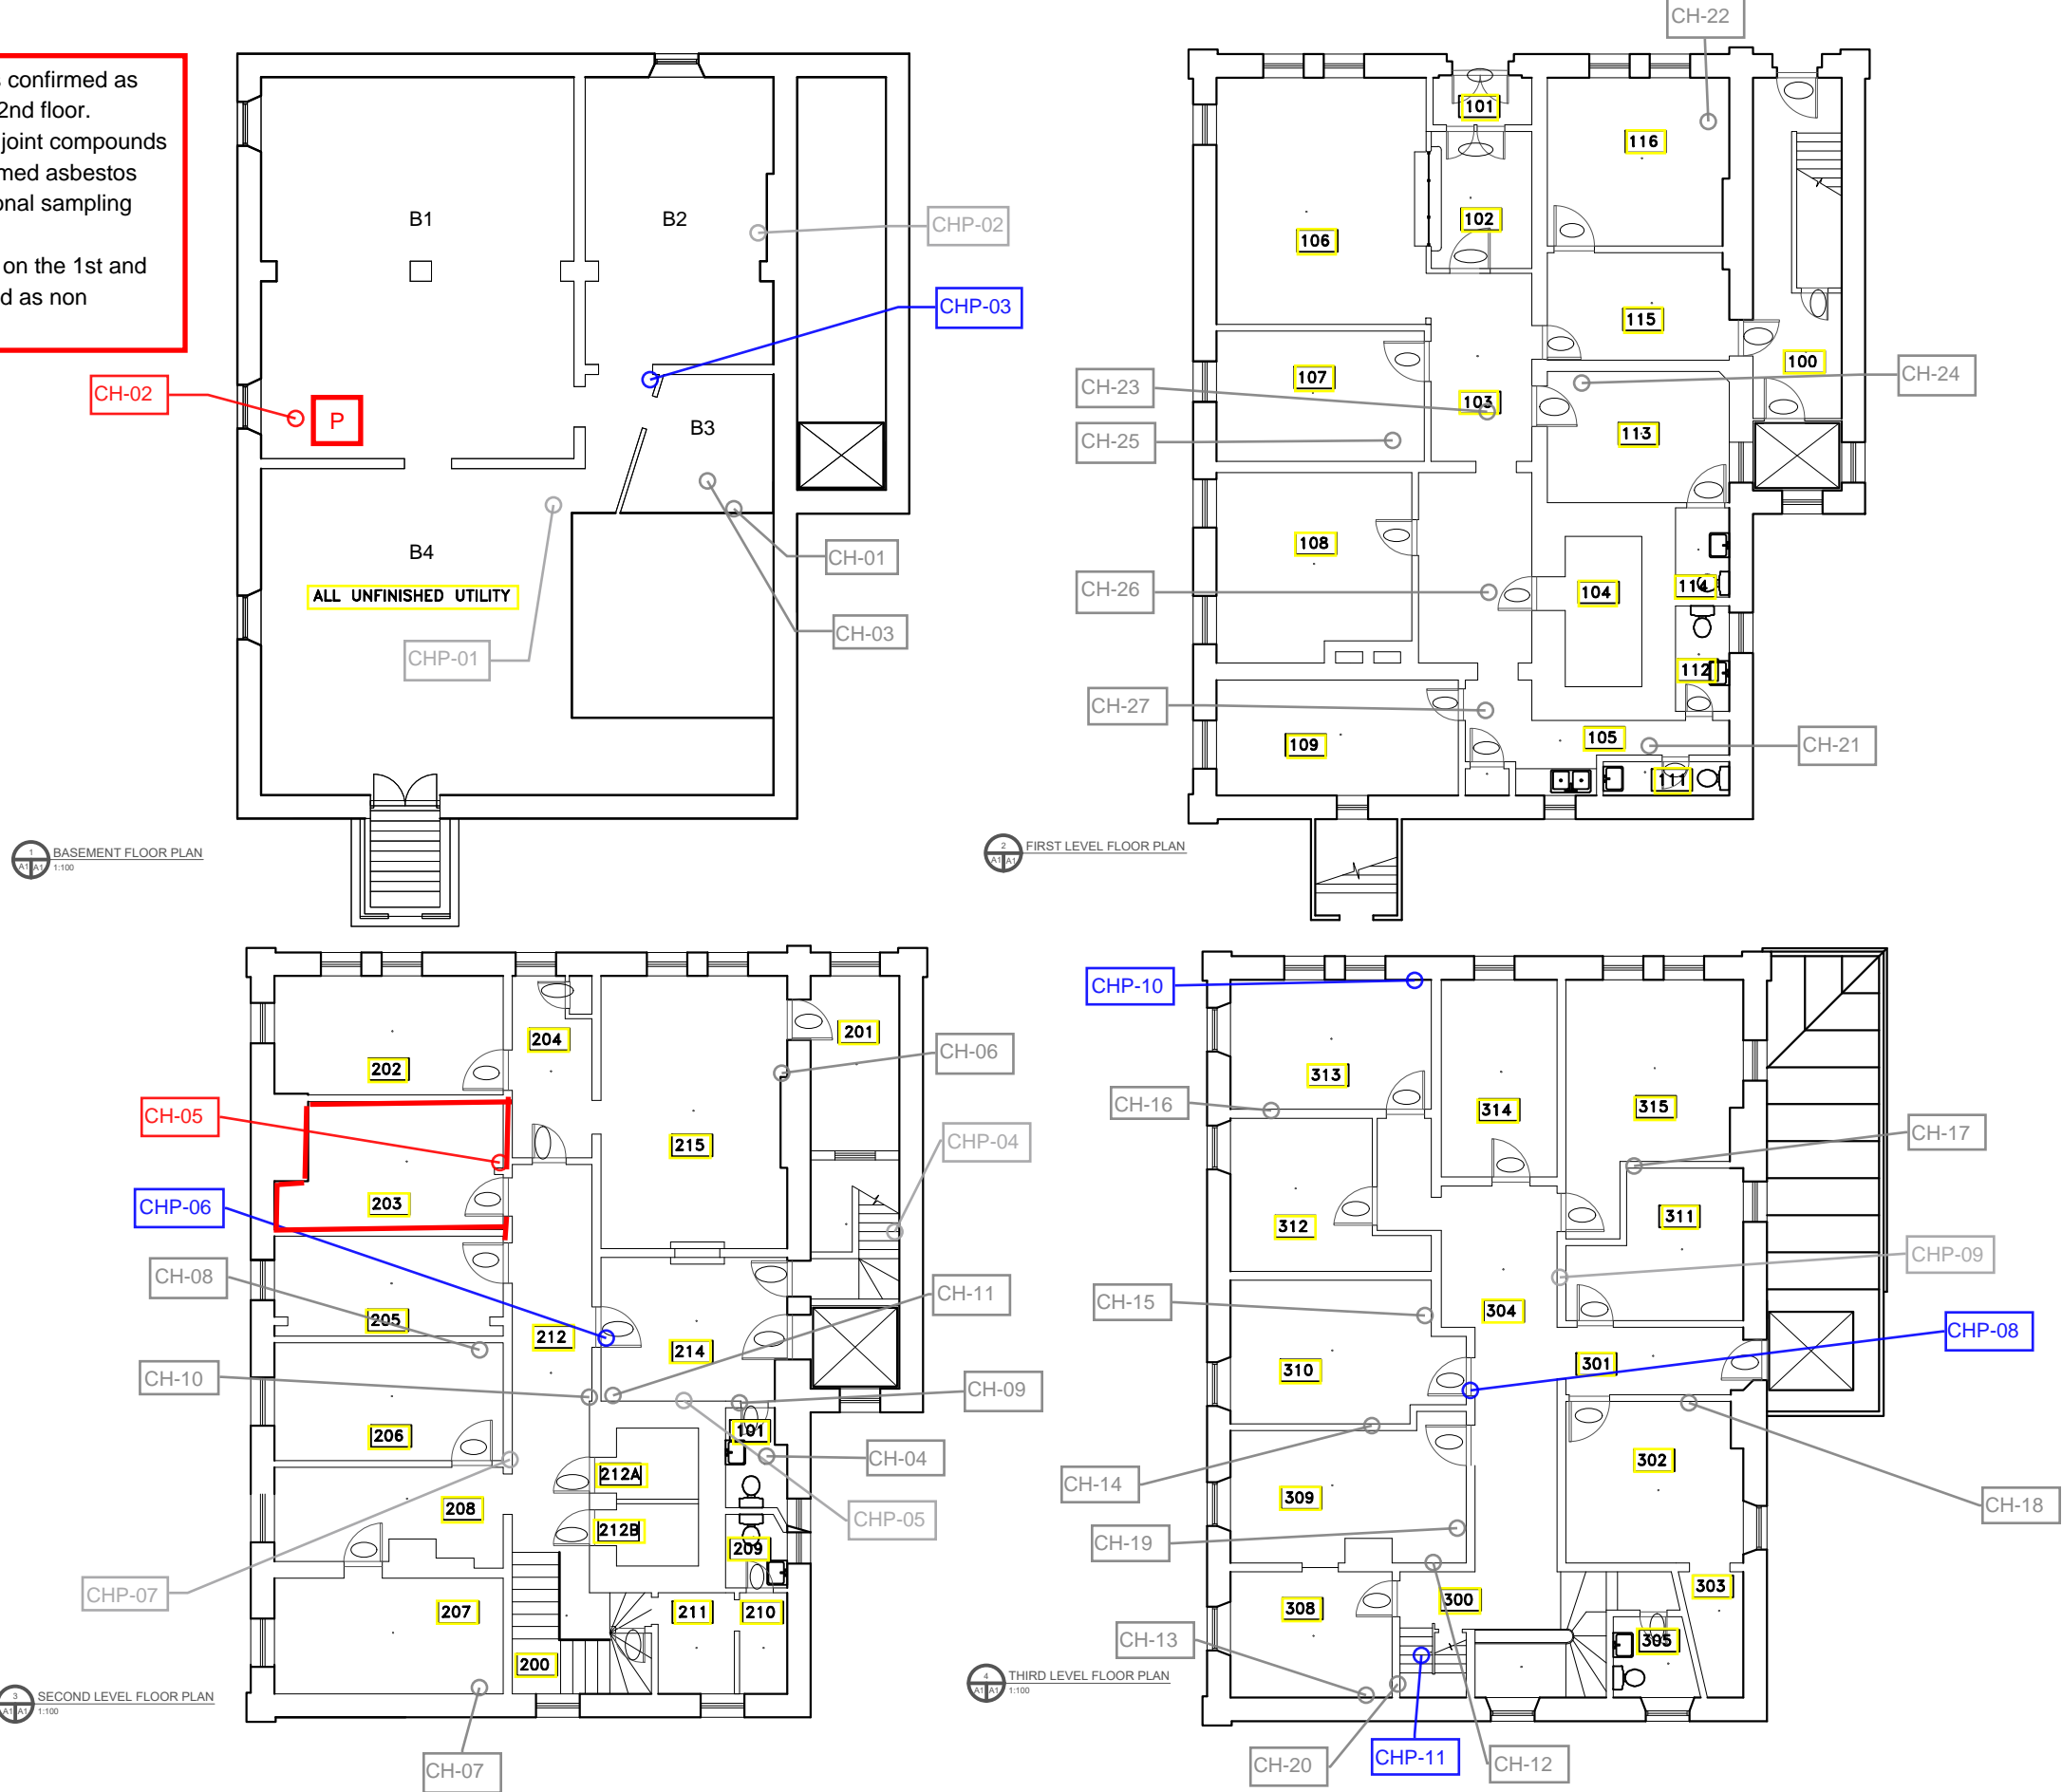
Site Drawings with sample locations and ACM locations

Drywall joint compounds confirmed as ACM in one location on 2nd floor. Therefore, other drywall joint compounds on 2nd floor to be presumed asbestos containing unless additional sampling proves otherwise. representative sampling on the 1st and 4th floor were all reported as non asbestos containing.
