# **HAZARDOUS MATERIALS ASSESSMENT**

## **Environmental Warehouse – Beach Grove**

### **25 Maypoint Road, Charlottetown, PE**

**ALL-TECH Project No.: PE22400**

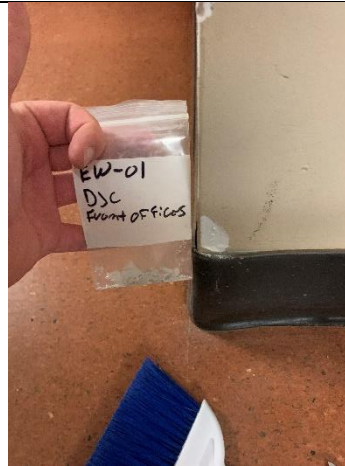
A total of four (4) joint compound samples were collected during the assessment. None of the samples were found to contain asbestos.

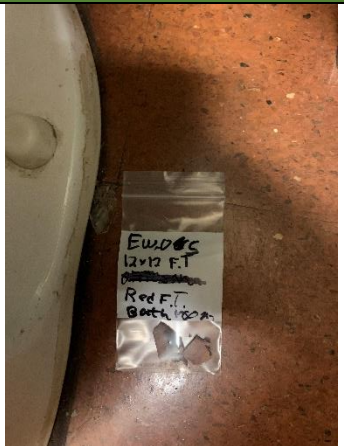
Sample No.:	Flooring Description	Location	Asbestos Type / Content (%)	Photo
EW-05	12" x 12" red vinyl floor tile with tan mastic	Bathroom	None Detected in floor tile or mastic

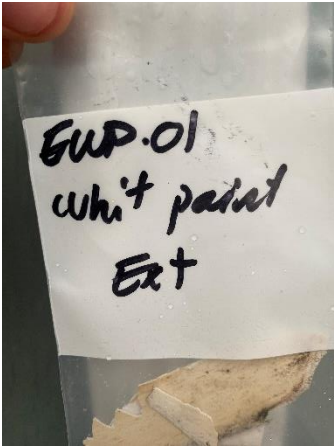
<i>Sample No.:</i>	<i>Colour / Substrate Description</i>	<i>Location</i>	<i>Lead Content (%)</i>	<i>Photo</i>
EWP-01	White trim paint	Exterior	0.052

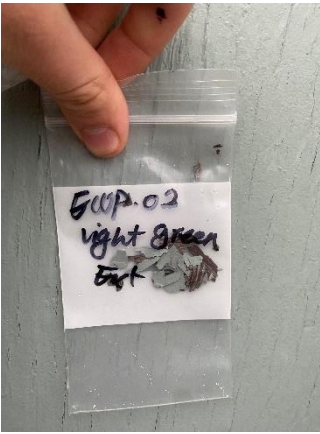
EWP-02	Light green siding paint	Exterior	0.03

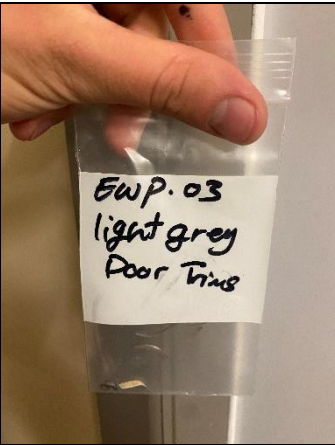
EWP-03	Light grey door trim paint	Exterior	< 0.0093

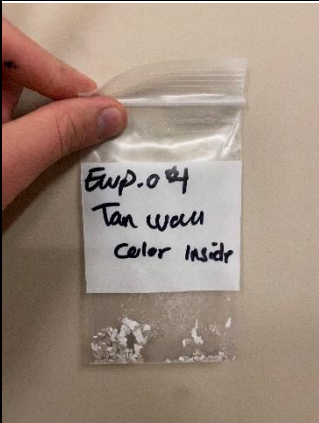
EWP-04	Tan colour wall paint	Office area	< 0.0071

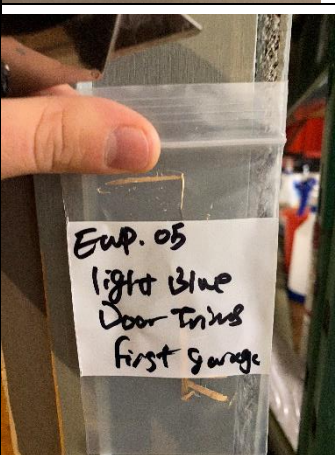
EWP-05	Light blue door trim paint	Garage bay area	< 0.0092

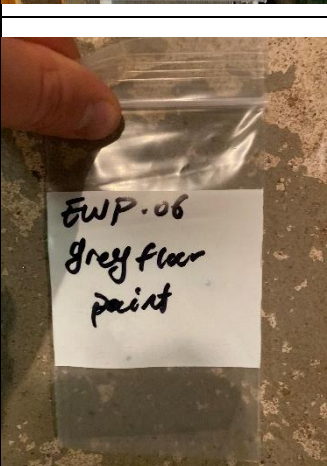
EWP-06	Grey floor paint	Garage bay area	0.0084

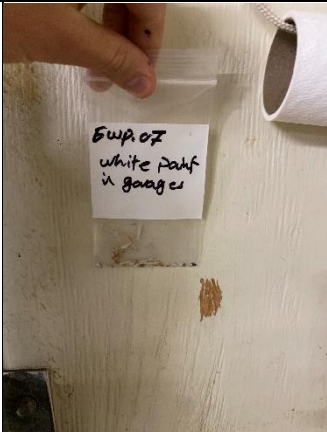
EWP-07	White wall paint	Garage bay area	0.015

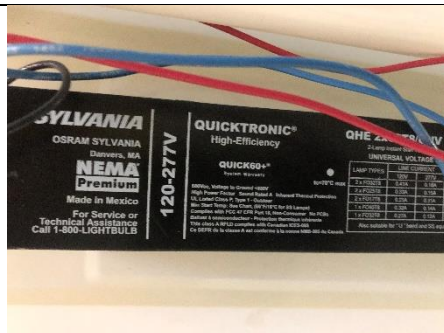
Photo 1 – Sylvania Quicktronic Lamp Ballasts – Ballast marked as No PCB's.

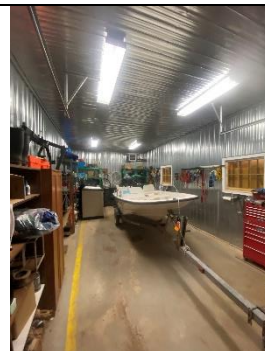
Photo 2 – Typical recessed light fixtures for these ballasts.
