## **HAZARDOUS MATERIALS ASSESSMENT**

### **Kings County Forestry Depot**

### **2580 Cardigan Road, Southampton, PE**

**ALL-TECH Project No.: PE22400**

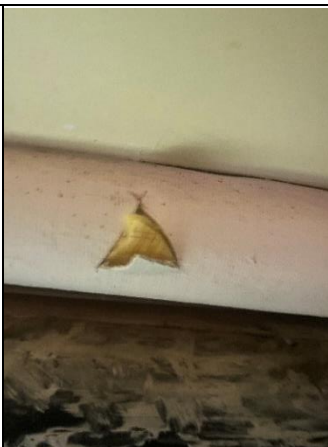
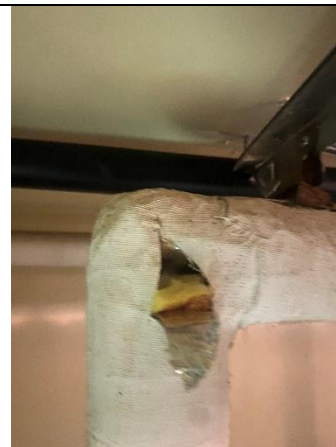
Office Building / Garage - straight sections as well as pipe fittings insulated with fiberglass insulation.

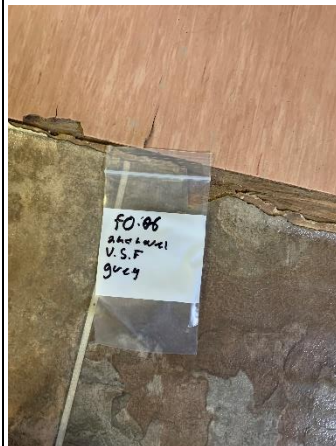
Sample No.:	Flooring Description	Location	Asbestos Type / Content (%)	Photo
FO-06	Grey vinyl sheet flooring	2 <sup>nd</sup> level	None Detected

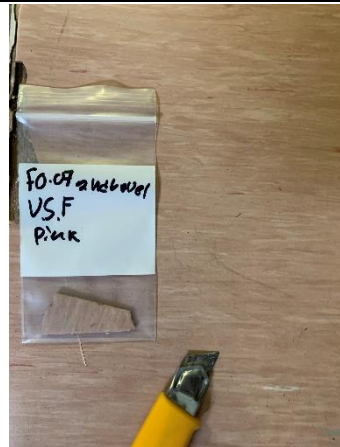
FO-07	Pink vinyl sheet flooring	2 <sup>nd</sup> level	None Detected

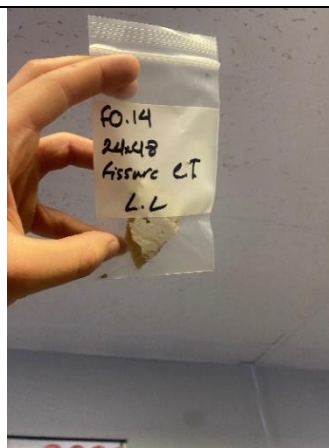
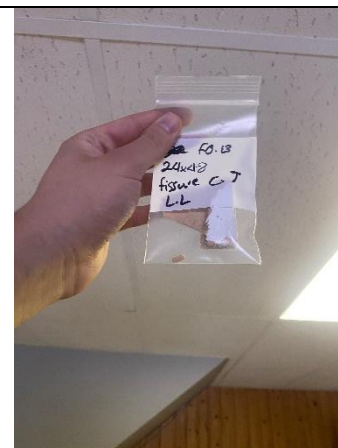
Ceiling tiles were noted and sampled in various random locations throughout the forestry depot office building. Representative sampling was completed on each floor of the building. A total of four (4) ceiling tile samples were collected during the assessment. None of the samples were found to contain asbestos.

Previous sample results of ceiling tiles in the limited garage areas were also reported as non-asbestos containing tiles.

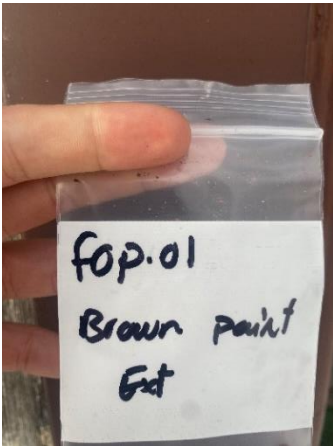
Sample No.:	Colour / Substrate Description	Location	Lead Content (%)	Photo
Forestry Depot Office				
FOP-01	Brown paint	Exterior	< 0.0080

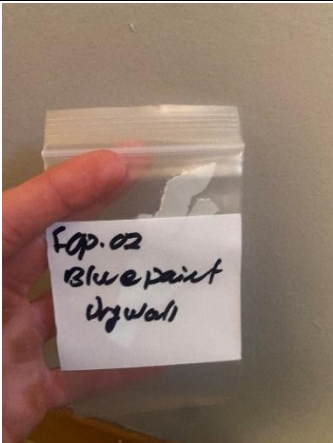
FOP -02	Light blue paint	Drywall	0.044

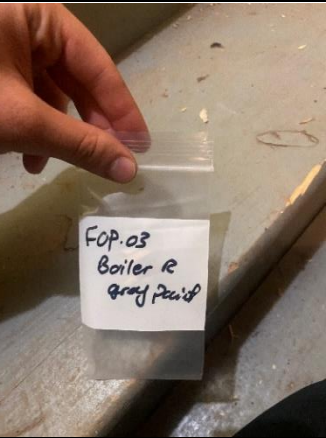
FOP -03	Grey paint	Boiler room	< 0.0086

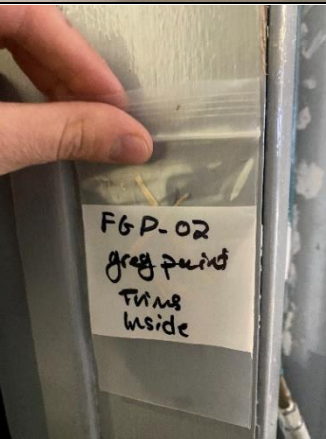
FGP -02	Grey trim paint	Garage	0.024

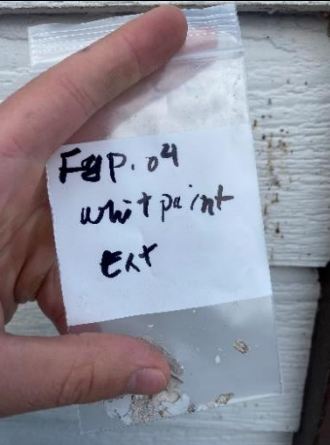
FGP -04	White siding paint	Exterior	< 0.0073

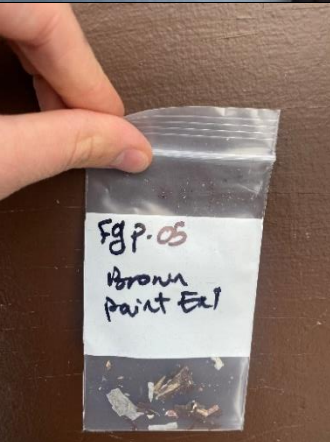
Based on the assessment findings, one (1) of the paint layers sampled on the garage exterior brown paint exceeded CEPA guidelines of 0.06 percent by weight for surface coating materials. Exceedances are noted in bold red in the table below.

FGP -05	Brown door paint	Exterior	0.19

Dispose of painted materials exceeding the criteria for leachable lead as hazardous waste.

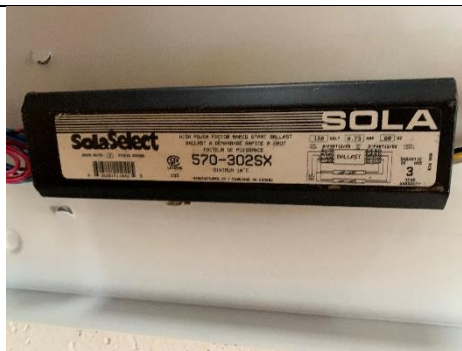
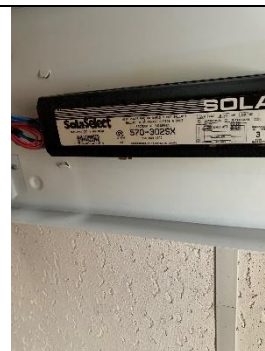
Typical ballasts inspected. Sola Selects Lamp Ballasts – Serial No.: 570-302SX. Ballast marked as non-PCB's.

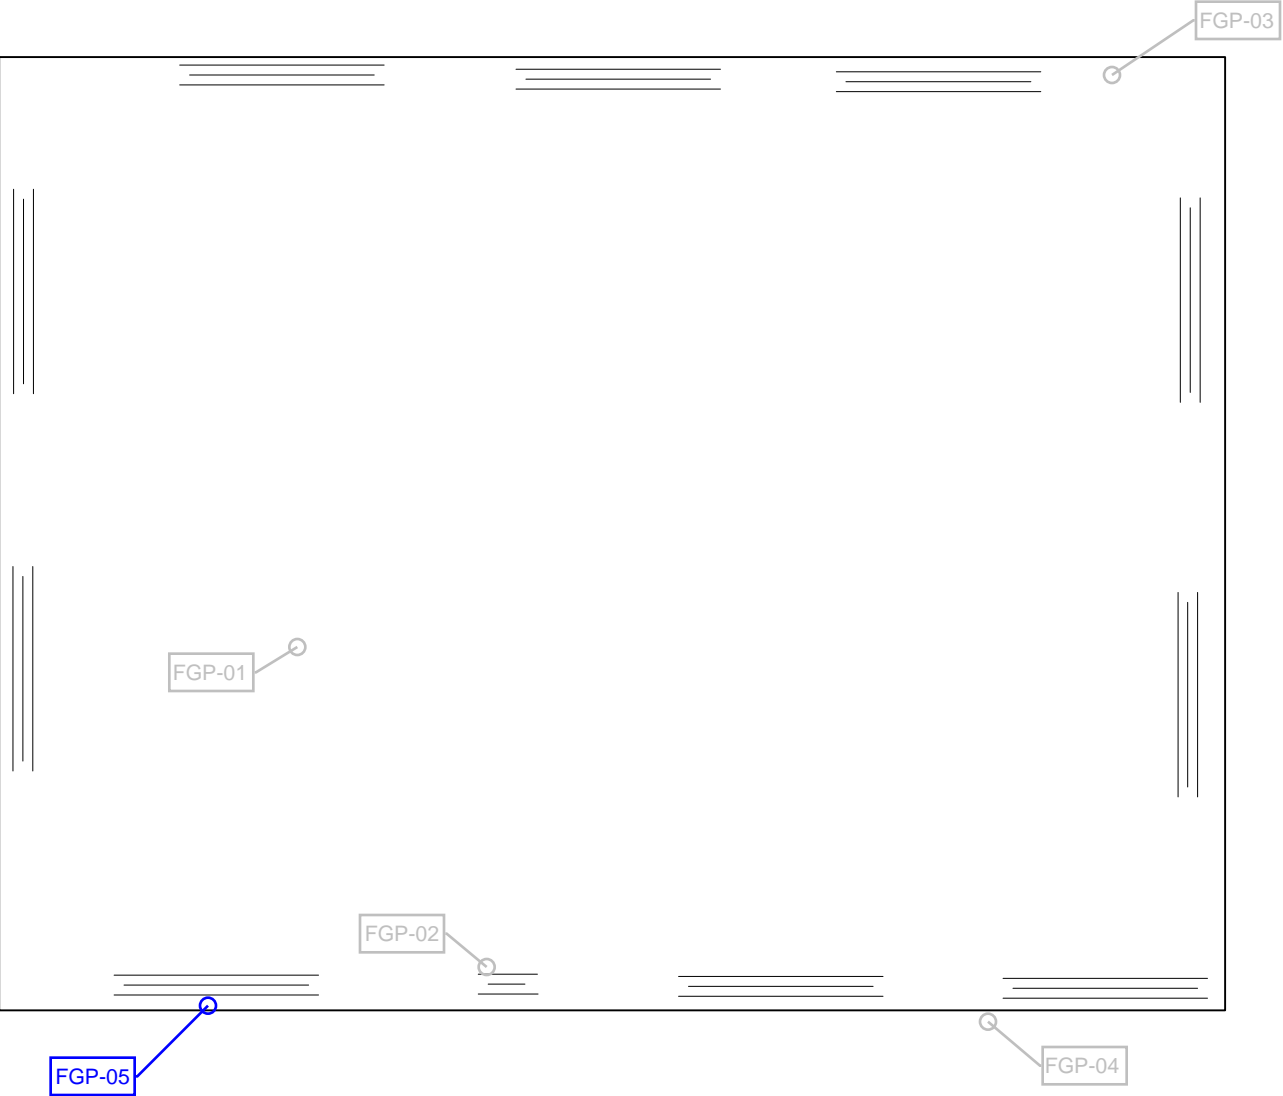
Note: Brown exterior door  
/ trim paint classified as  
lead based paint
