# **HAZARDOUS MATERIALS ASSESSMENT**

## **Lea Crane Building**

### **167 East Street,**

**ALL-TECH Project No.: PE22400**

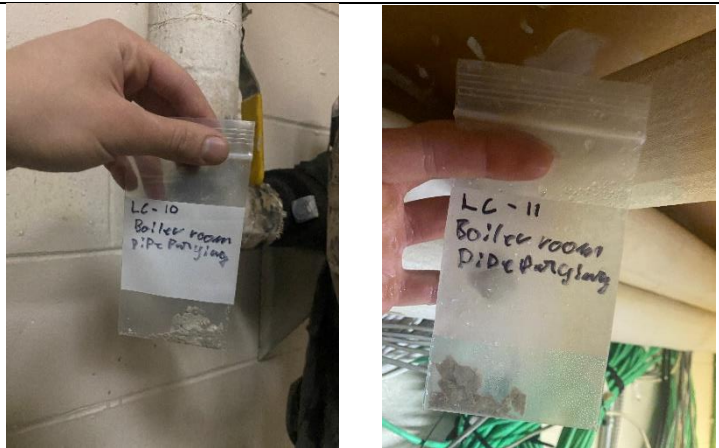
| <p>Parging cement is present on pipe fittings throughout boiler room. Representative samples were collected and none were found to contain asbestos (samples LC-09 – LC-11). Additional like materials all considered to be non-asbestos containing.</p> | |

Straight sections of pipe are insulated with fiberglass.

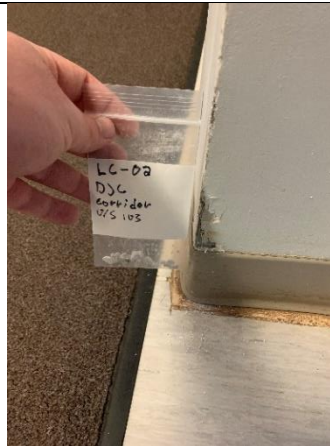
Drywall joint compound walls and ceilings were noted and sampled in various random locations throughout the building. Representative sampling was completed within the building. A total of none (9) joint compound samples were collected during the assessment. None of the samples were found to contain asbestos.

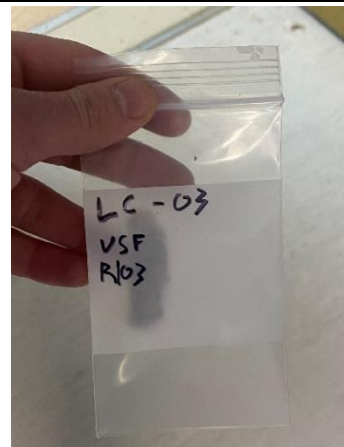
| Sample No.: | Flooring Description | Location | Asbestos Type / Content (%) | Photo |
|---|---|---|---|---|
| LC-03 | White vinyl sheet flooring | Room 103 | None Detected | |

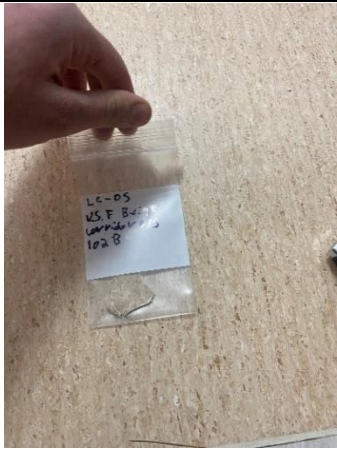
| LC-05 | Tan vinyl sheet flooring | Corridor outside room 102B | None Detected | |

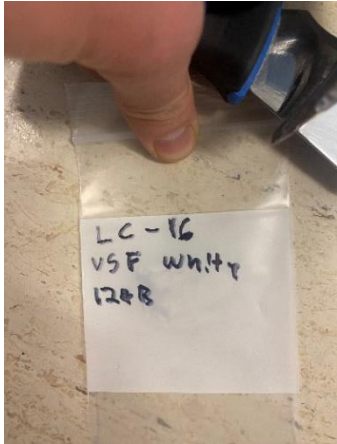
| LC-16<br>LC-22 | White Vinyl Sheet flooring | Room 124B<br>Room 117 | None Detected | |

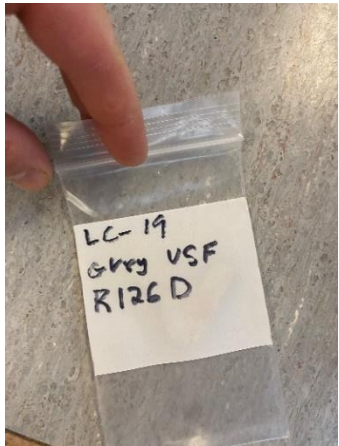
| LC-06<br>LC-19<br>LC-24 | Blue Vinyl sheet flooring | Room 115<br>Room 126D<br>Room 120 | None Detected | |

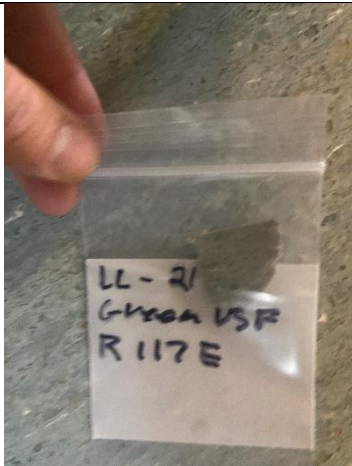
| LC-21 | Green Vinyl sheet flooring | Room 121 | None Detected | |

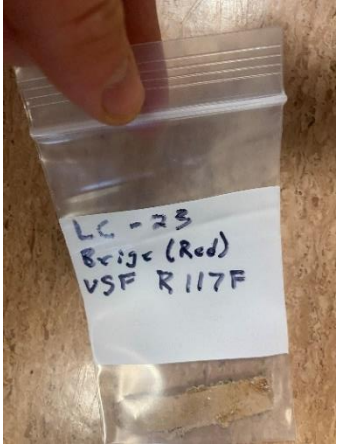
| LC-23 | Tan Vinyl sheet flooring | Room 122 | None Detected | |

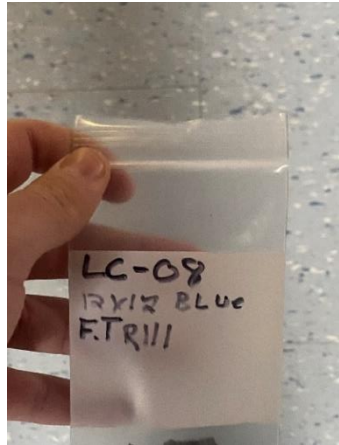
| Sample No.: | Flooring Description | Location | Asbestos Type / Content (%) | Photo |
|---|---|---|---|---|
| LC-01<br>LC-08 | 12" x 12" blue floor tile | Room 102<br>Room 111 | None Detected | |

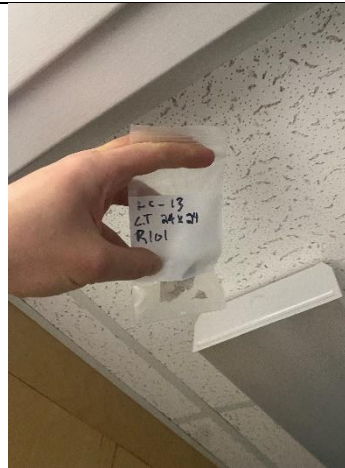
Acoustic ceiling tile was only noted in one location throughout the assessed areas. The ceiling tile area was sampled and found to be non-asbestos containing. Additional like materials considered to be non-asbestos containing.

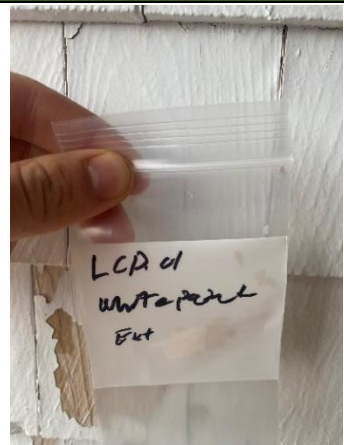
| Sample No.: | Colour / Substrate Description | Location | Lead Content (%) | Photo |
|---|---|---|---|---|
| LCP-01 | White paint | Exterior | <0.0075 | |

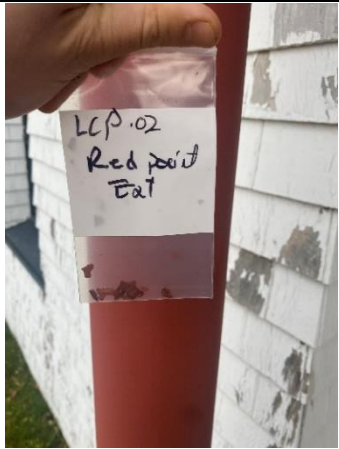
Based on the assessment findings, one (1) of the paint layers sampled exceeded CEPA guidelines of 0.06 percent by weight for surface coating materials. Exceedances are noted in bold red in the table below.

| LCP-02 | Red paint on exterior post / trim | Exterior | 0.39 | |

Dispose of painted materials exceeding the criteria for leachable lead as hazardous waste.

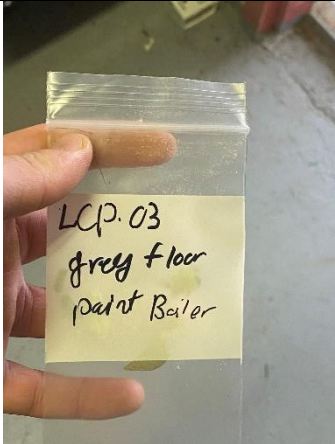
| LCP-03 | Grey paint floor | Boiler room | 0.0083 | |

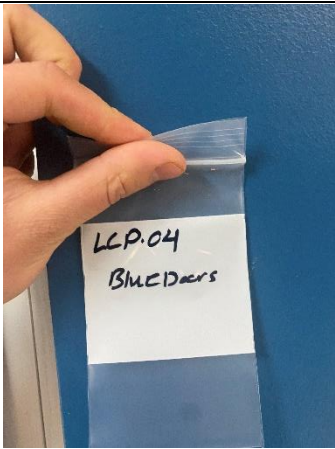
| LCP-04 | Blue paint | Doors | <0.015 | |

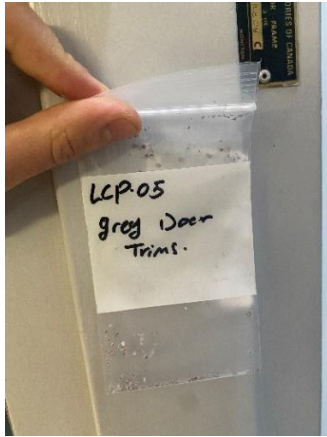
| LCP-05 | Grey paint | Door trims | <0.0084 | |

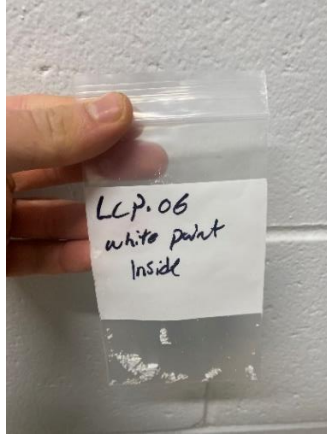
| LCP-06 | White Paint | Interior | <0.015 | |

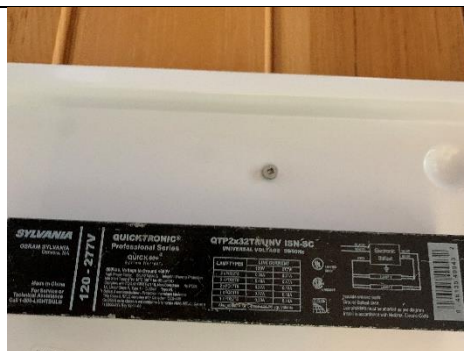
Photo 1

Phot 1 - SYLVANIA Quicktronic Lamp Ballasts – Manufacturers labelled as No PCB's.

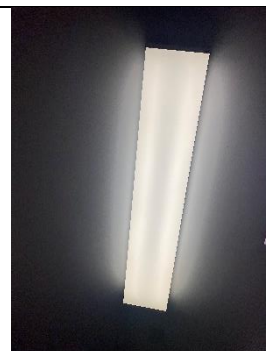
Photo 2 – Typical light fixtures for these ballasts.

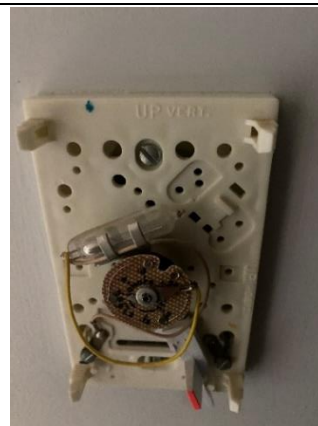
Phot 1 – Mercury containing thermostat present

Do not break lamps or separate liquid mercury from components. Recycle and reclaim mercury from fluorescent lamps and thermostats when taken out of service. Mercury is classified as a hazardous waste and must be disposed of in accordance with applicable regulations.

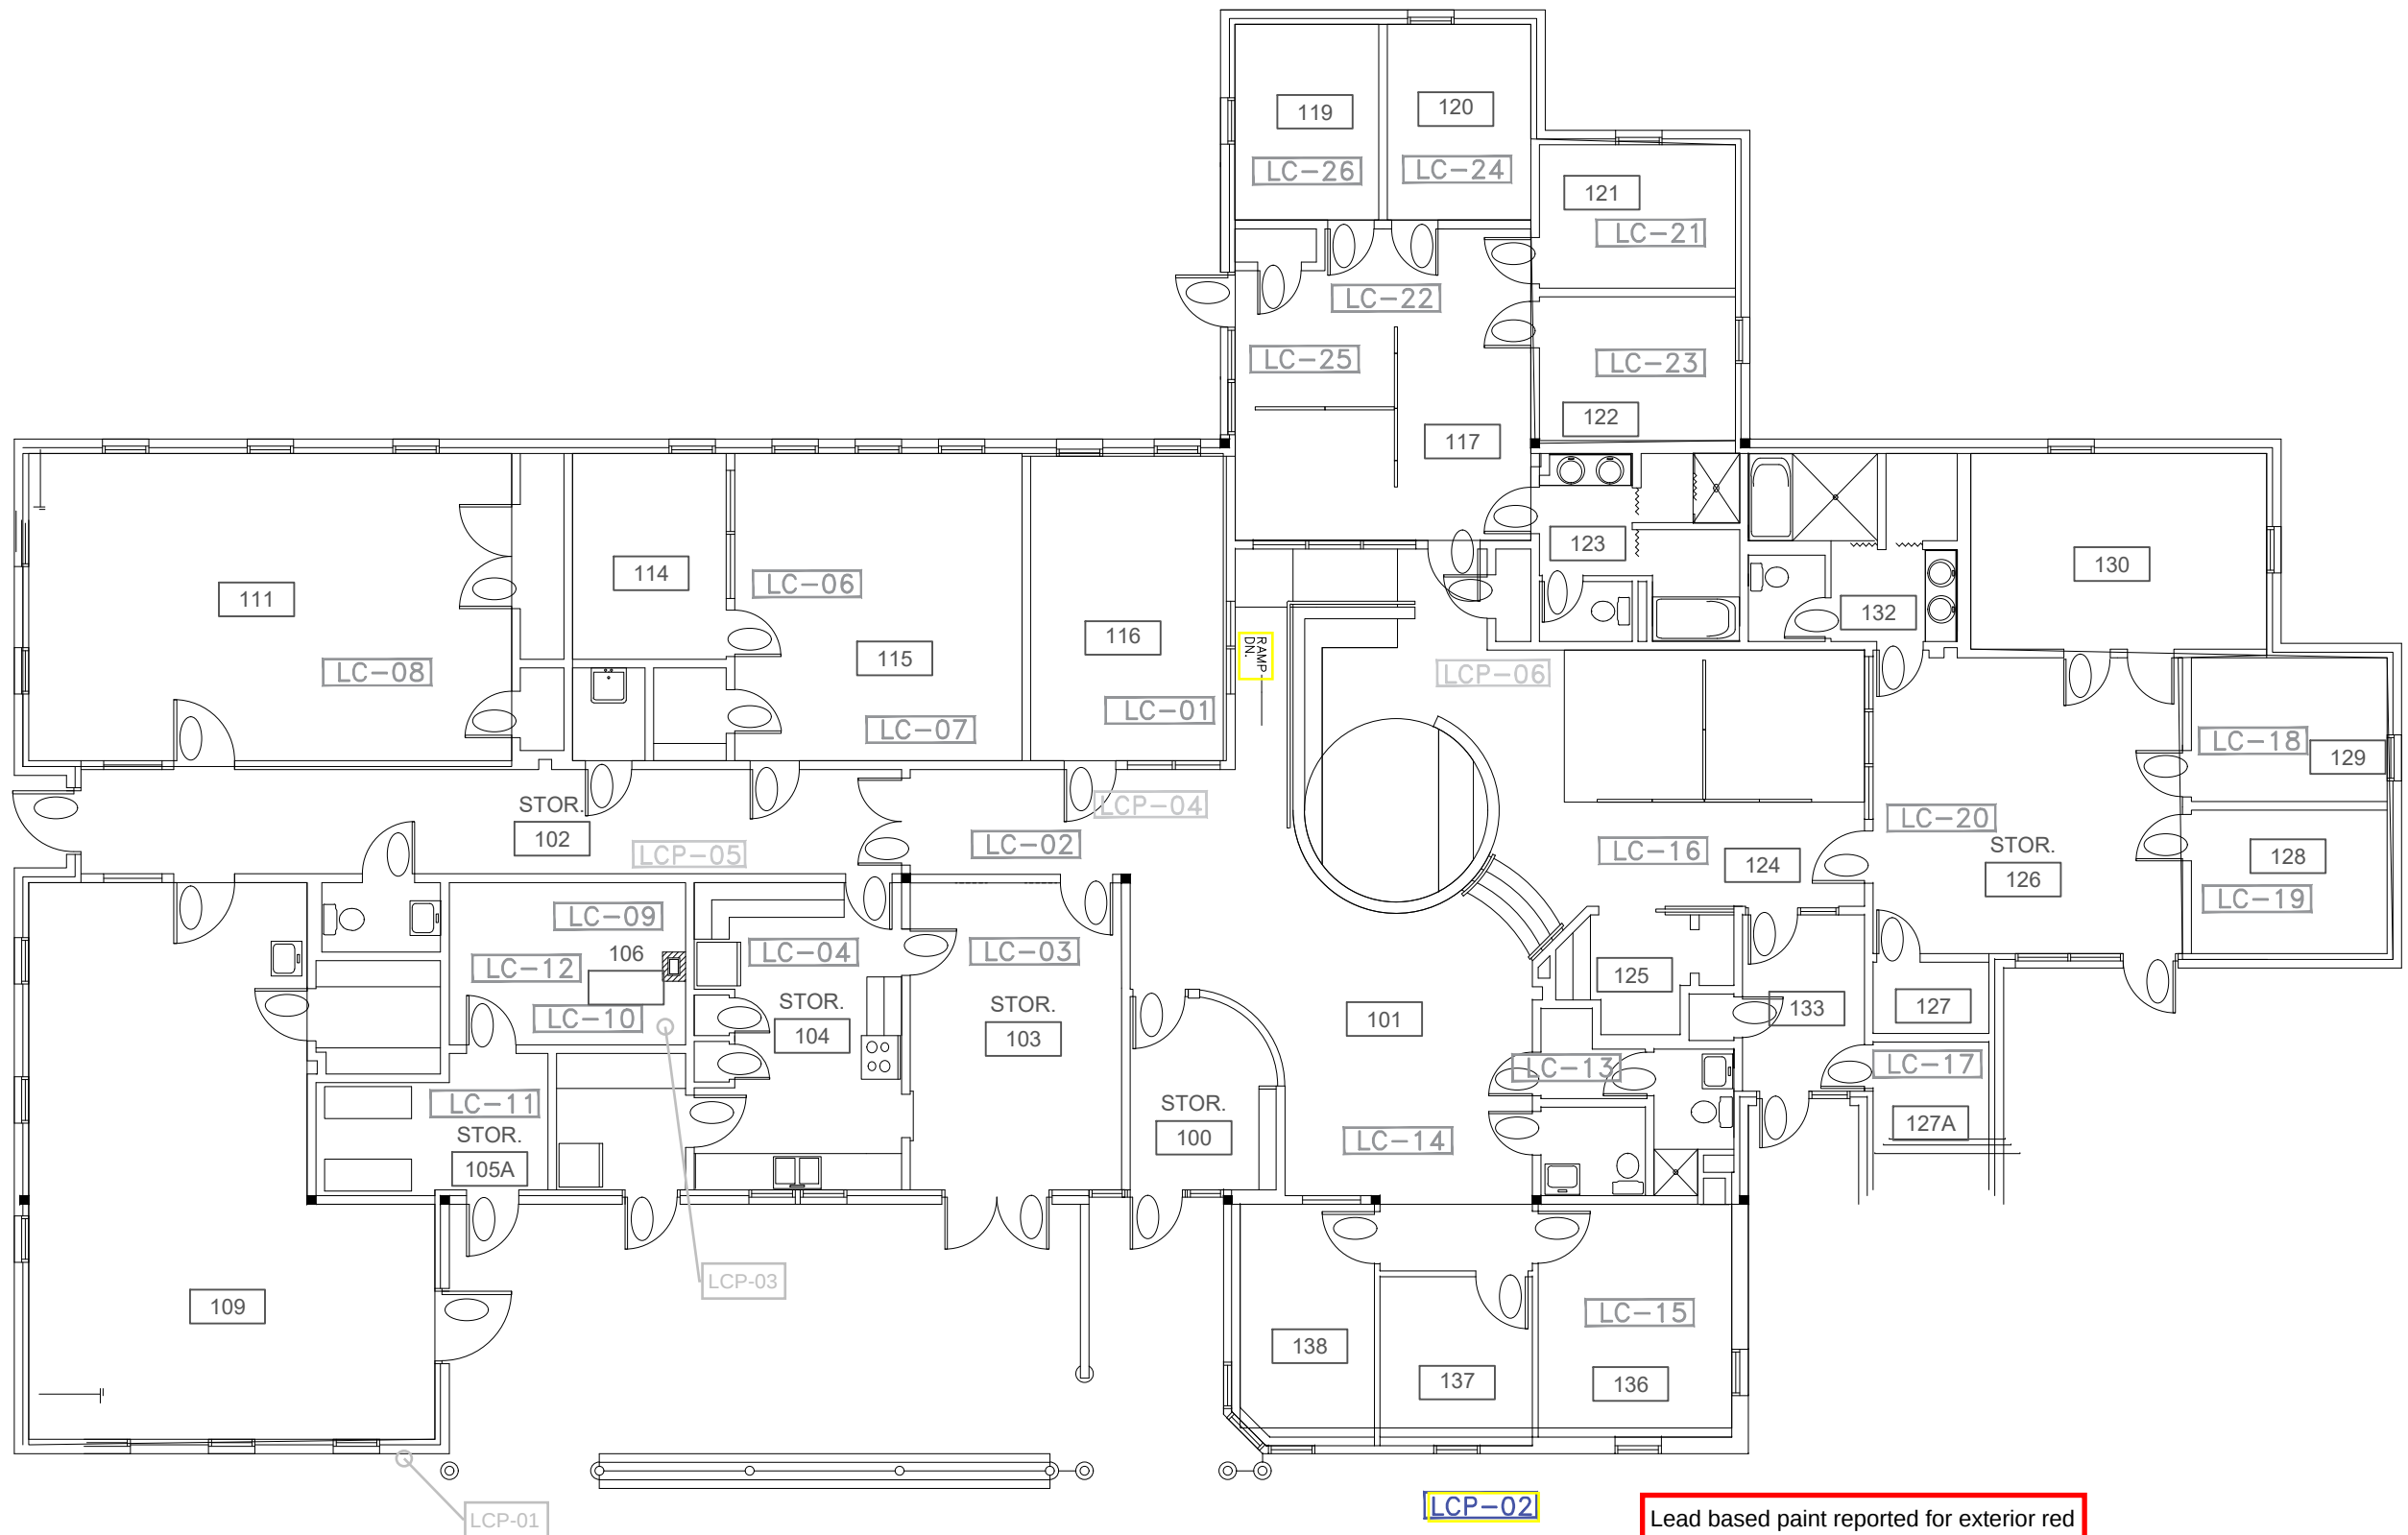
Lead based paint reported for exterior red  
trim paint.
