## **HAZARDOUS MATERIALS ASSESSMENT Montague Office Complex 126 Douses Road, Montague, PE**

**March 29, 2023**

**ALL-TECH Project No.: PE22400**

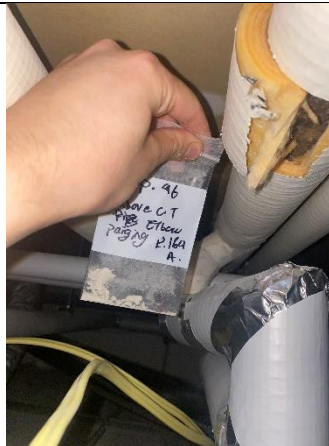
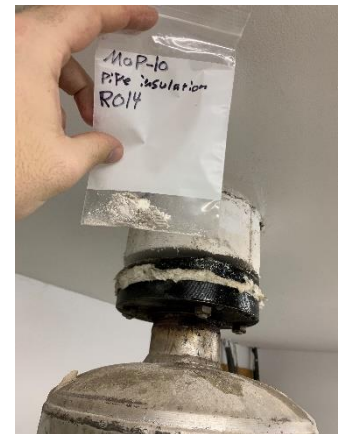
Parging cement is present on pipe fittings in various locations throughout the building. A total of seven (7) samples of parging cement were collected and none were found to be asbestos containing. Based on the age of the building and representative samples collected, all other like materials should be considered to be non-asbestos containing.

Parging cement on pipe fittings of fiberglass pipe

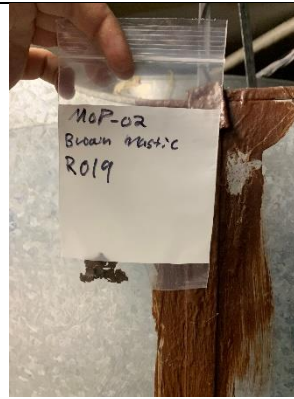
Ducts were observed as non-insulated with brown mastic on seams. Three (3) samples were collected of this material. None were found to be asbestos containing.

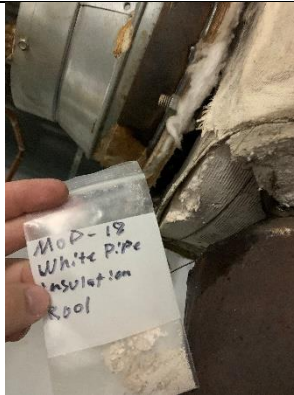
Mechanical insulation (breaching) sampled as non-asbestos containing material.

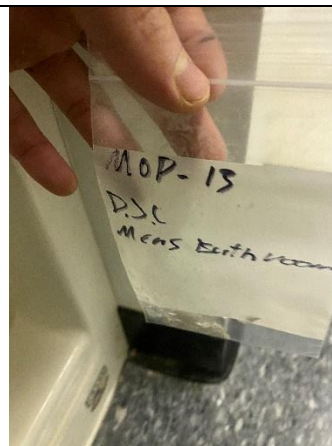
A total of twenty (20) joint compound samples were collected during the assessment. None of the samples were found to be asbestos containing.

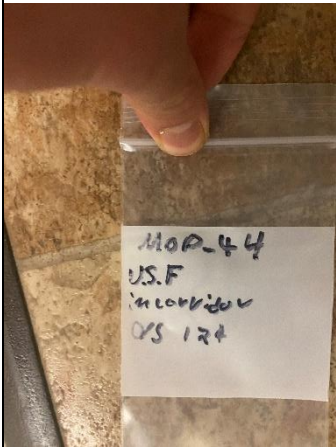
| Sample No.: | Flooring Description | Location | Asbestos Type / Content (%) | Photo |
|---|---|---|---|---|
| MOP-44 | Off-white vinyl sheet flooring | Corridor outside room 124 | None Detected | |

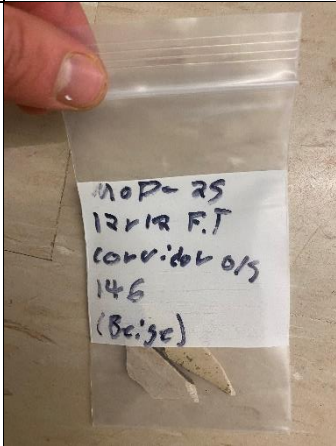
| Sample No.: | Flooring Description | Location | Asbestos Type / Content (%) | Photo |
|---|---|---|---|---|
| MOP-25<br>MOP-38 | Beige Floor tile | Corridor outside room 146 | None Detected | |

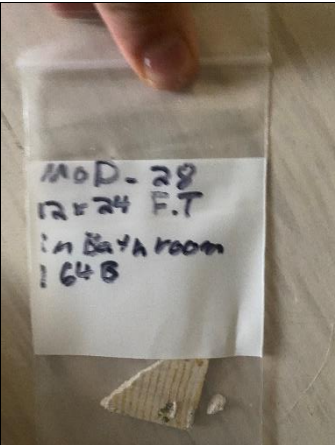
| MOP-28 | White / Grey floor tile | Bathroom / Room 164b | None Detected | |

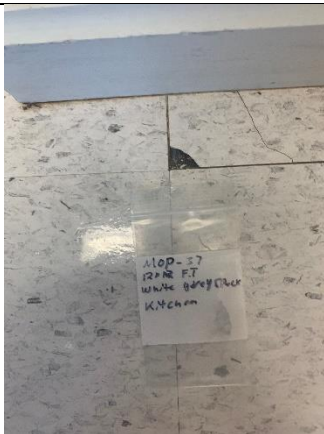
| MOP-33<br>MOP-37 | Off white / grey floor tile | Main level / Kitchen | None Detected | |

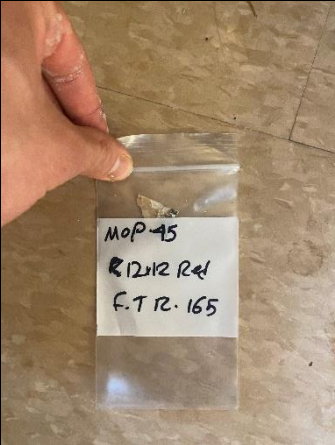
| MOP-45 | Orange floor tile | Room 165 | None Detected | |

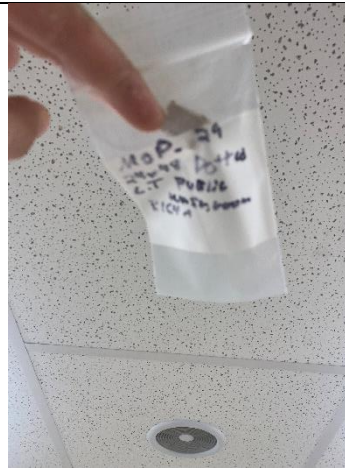
A total of five (5) fissure and dotted design ceiling tiles were collected during the assessment. None of the samples were found to be asbestos containing.

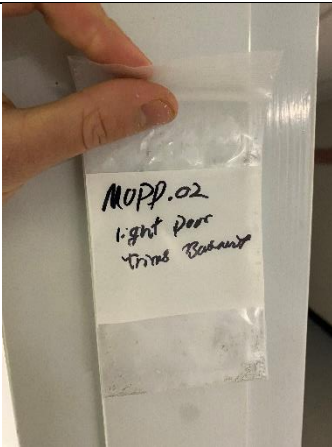
| MOPP-02 | White door trim | Basement | <0.013 | |

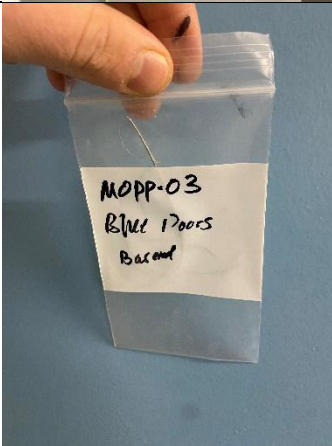
| MOPP-03 | Blue door paint | Basement | <0.015 | |

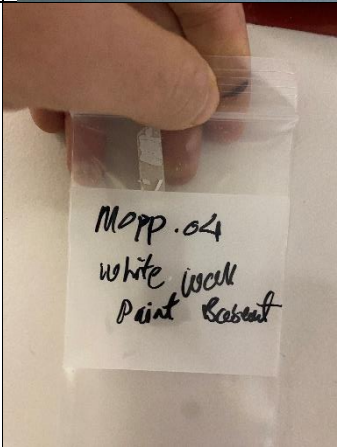
| MOPP-04 | White wall paint | Basement | 0.022 | |

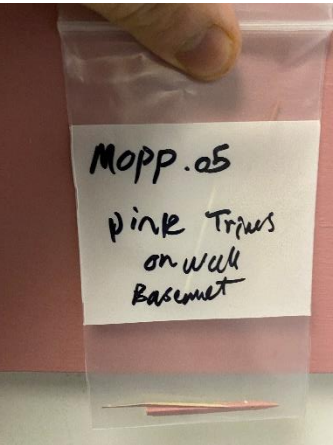
| MOPP-05 | Pink trims on the wall | Basement | <0.0075 | |

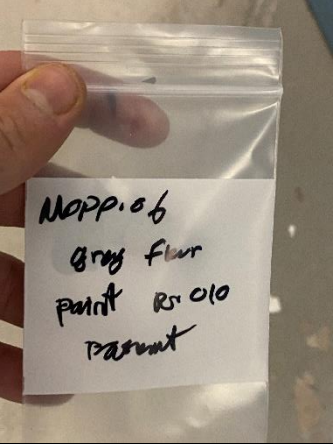
Based on the assessment findings, two (2) of the paint layers sampled exceeded CEPA guidelines of 0.06 percent by weight for surface coating materials. Exceedances are noted in bold red in the table below.

| MOPP-06 | Grey paint on concrete floor | Room 010/ basement | 0.063 | |

Dispose of painted materials exceeding the criteria for leachable lead as hazardous waste.

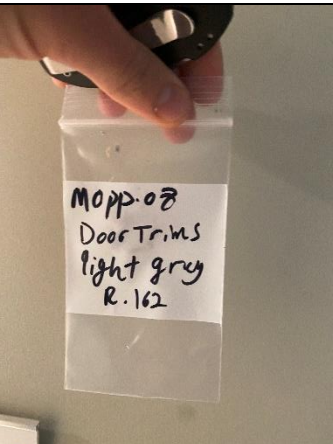
| MOPP-08 | Light grey door trims | Room 162 | <0.0089 | |

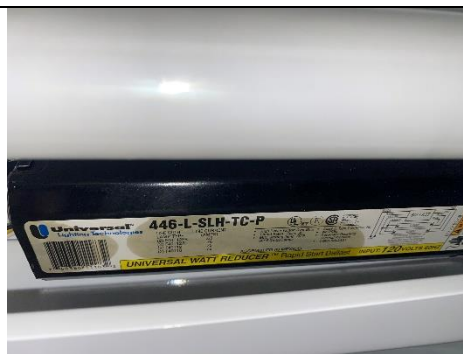
Photo 1

Phot 1 - Universal Lamp Ballasts – Manufacturers labelled as No PCB's.

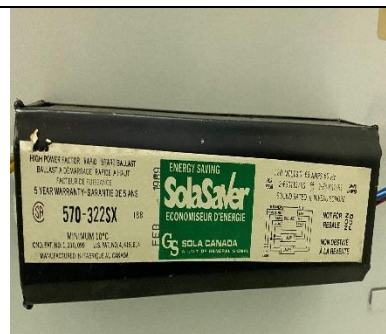
Photo 2 – Solar Saver Lamp Ballasts – Manufacturers labelled as No PCB's.

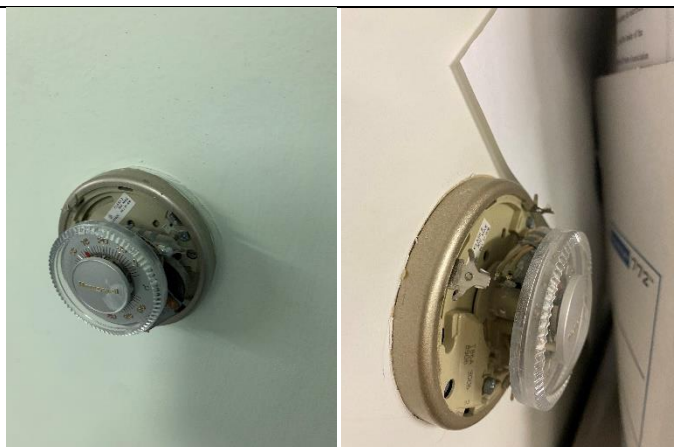
Mercury containing thermostats present.

Do not break lamps or separate liquid mercury from components. Recycle and reclaim mercury from fluorescent lamps and thermostats when taken out of service. Mercury is classified as a hazardous waste and must be disposed of in accordance with applicable regulations.
