HAZARDOUS MATERIALS ASSESSMENT

Prince County Courts Building

108 Central Street, Summerside, PE

ALL-TECH Project No.: PE22400

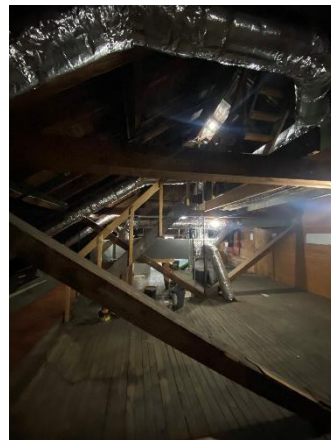
Photo 1

Newer flexible foil duct observed in attic space. No suspect ACM duct insulations observed or reported in accessible areas (photo 1).

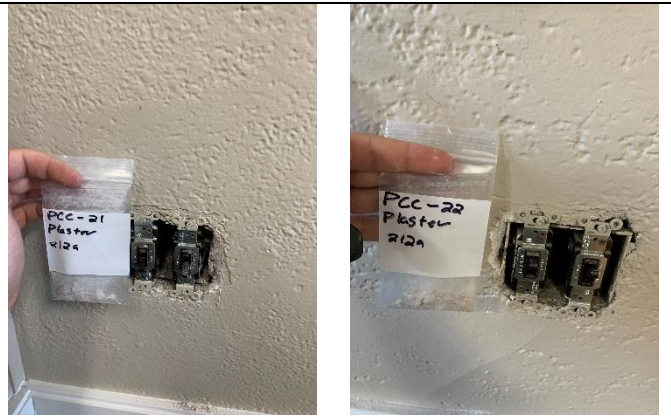
A total of nineteen (19) plaster samples were collected with both the white scratch coat and underlying base coats analyzed. **Two of the white scratch coat samples were found to contain 2.3% - 2.5% Chrysotile asbestos (samples PCC-21 & PCC-22). One of the brown base coat samples was found to contain 1.1% Chrysotile asbestos (sample PCC-27).**

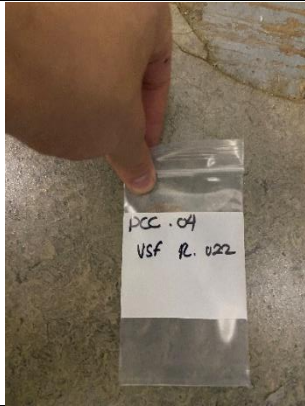
Sample No.:	Flooring Description	Location	Asbestos Type / Content (%)	Photo
Courthouse & Jail				
PCC-04	Brown vinyl sheet flooring with tan mastic	Room 022	None Detected in flooring or mastic

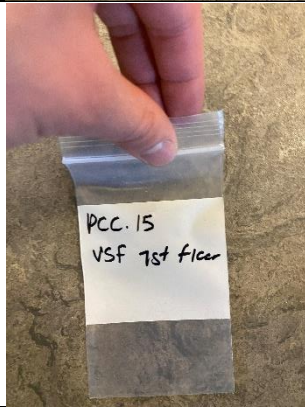
PCC-15	Beige vinyl sheet flooring	1 st floor	None Detected

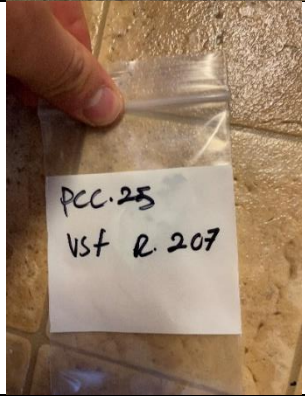
PCC-25	Tan vinyl sheet flooring with yellow mastic	Room 207	None Detected in flooring or mastic

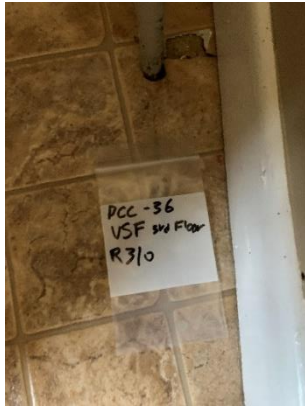
PCC-36	Beige vinyl sheet flooring with yellow mastic	Room 310	None Detected in flooring or mastic

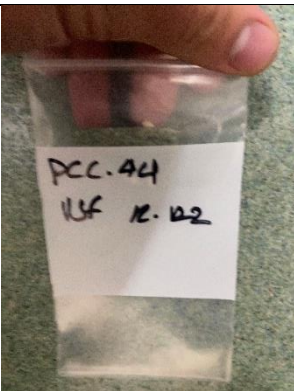
PCC-44	Green vinyl sheet flooring with yellow mastic	Room 122	None Detected in flooring or mastic

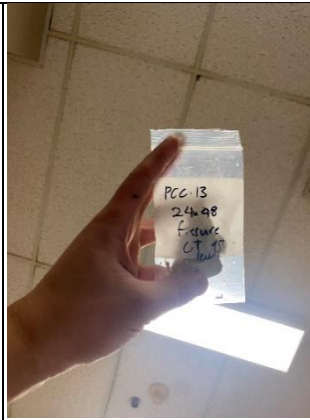
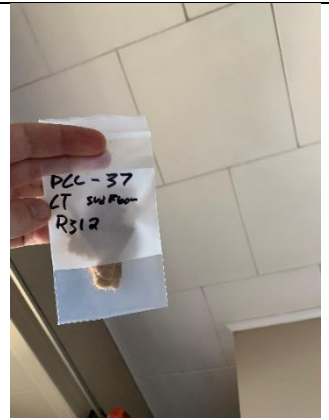
Limited areas of ceiling tiles were observed during the assessment. Some in-lay acoustic ceilings were noted and sampled on the 1st floor. The tiles were sampled and analyzed as non-asbestos containing. Other areas were noted with 12" x 12" plain fixed ceiling tiles. These tiles were sampled and analyzed as non-asbestos containing.

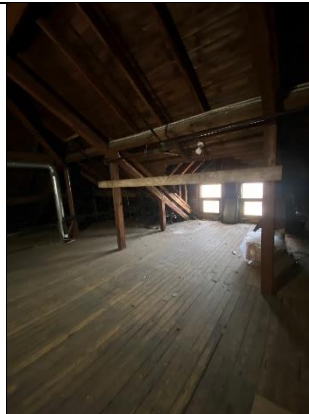
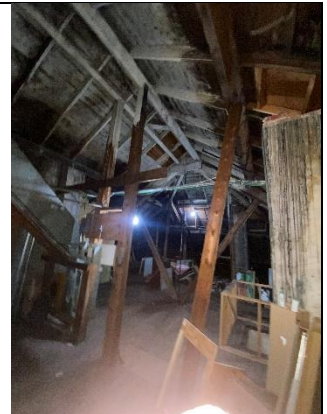
Attic space wood structure and flooring. No suspect ACM.

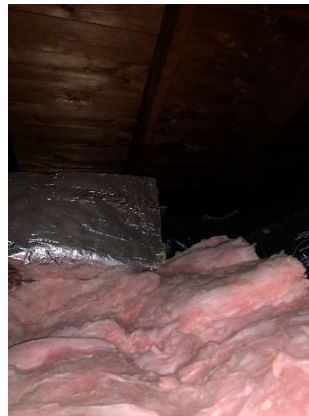
No other suspect building materials were observed or reported.
Attic insulation visibly identified as fiberglass.

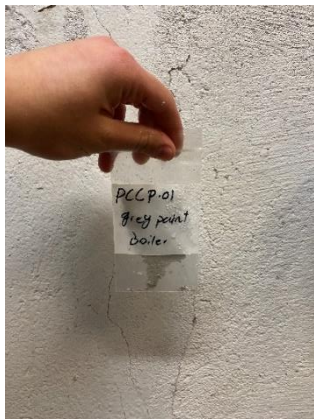
Sample No.:	Colour / Substrate Description	Location	Lead Content (%)	Photo
Court House & Jail				
PCCP-01	Grey paint / Wall surface	Boiler room	0.19

Dispose of painted materials exceeding the criteria for leachable lead as hazardous waste.

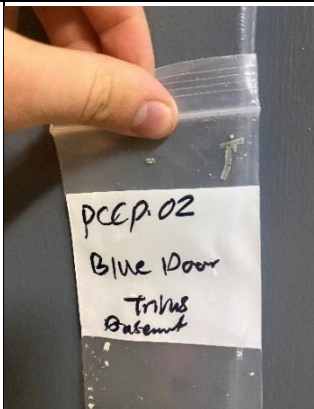
PCCP -02	Blue paint / Door trim	Basement	< 0.018

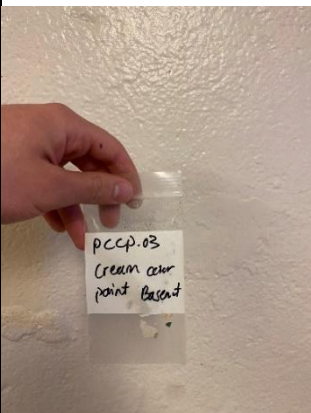
PCCP -03	Cream paint / Wall surface	Basement	0.70

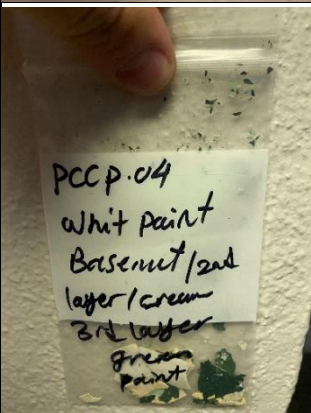
PCCP -04	White cream with green paint / Wall surface	Basement	1.1

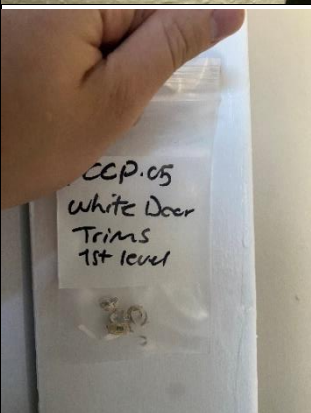
PCCP -05	White paint / Door trim	1 st level	0.051

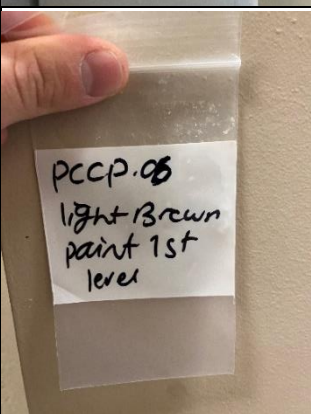
PCCP -06	Light brown paint / Wall surface	1 st level	<0.0064

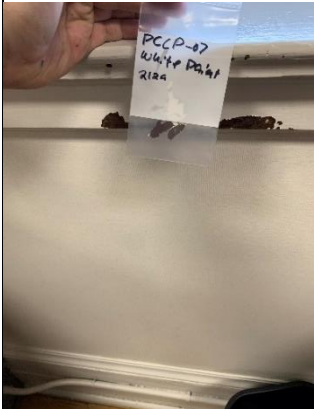
PCCP -07	White paint / Trim	Room 202	0.055

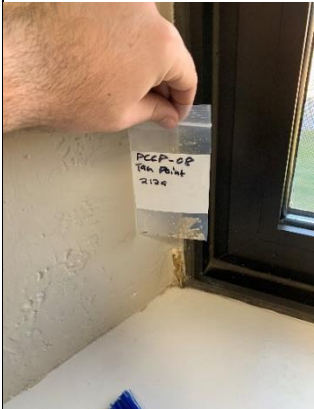
PCCP -08	Tan paint / Wall surface	Room 203	3.8

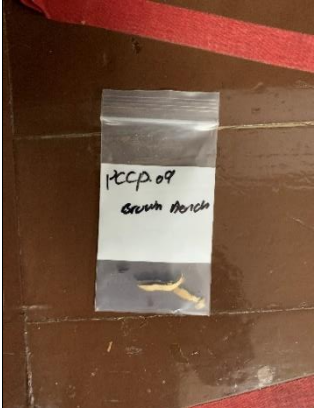
PCCP -09	Brown paint / Wood bench	Room 212	6.4

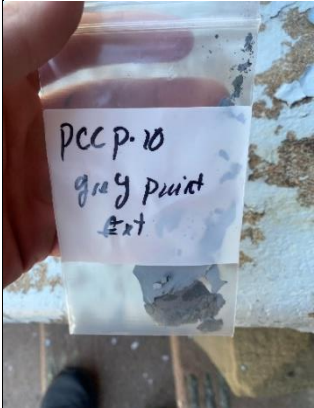
PCCP -10	Grey paint / Trim	Exterior	1.1

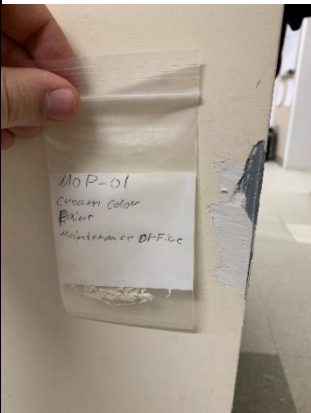
Maintenance & Sheriff's office				
MOP-01	Cream color paint / Wall surface	Maintenance office	<0.0097

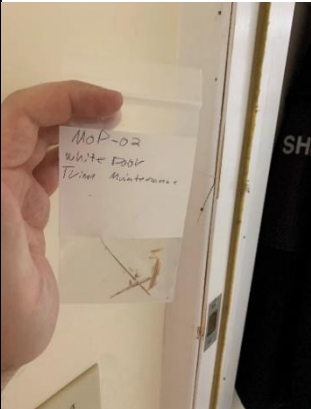
MOP-02	White paint / Door trim	Maintenance office	<0.0077

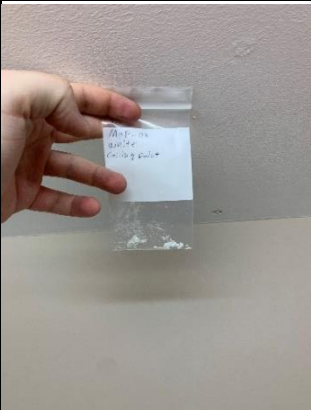
MOP-03	Brown paint / Wall surfaces	Sheriff's office	<0.0077	NA
MOP-04	White paint / Ceiling	offices	<0.0078

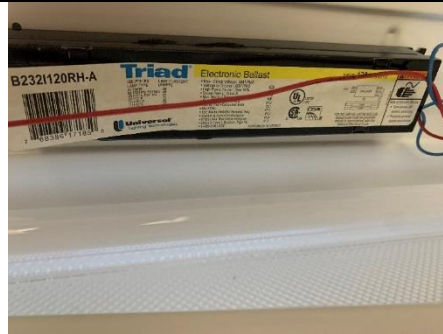
Photo 1 – Typical ballasts noted as Triad Lamp Ballasts. Manufacturers label marked as No PCB's.
