## **HAZARDOUS MATERIALS ASSESSMENT**

### **Prince County Forestry Depot**

**40 Hackmatack Rd,  
Wellington Station, PE**

**ALL-TECH Project No.: PE22400**

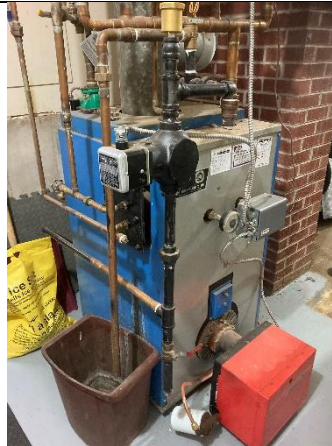
Office Building boiler system

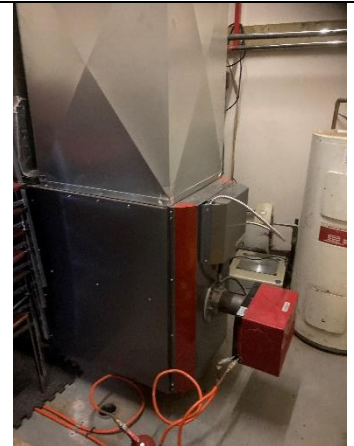
Garage furnace system

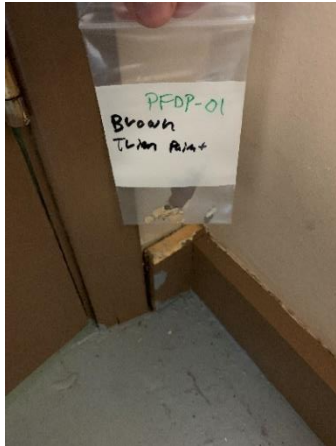
| Sample No.: | Colour / Substrate Description | Location | Lead Content (%) | Photo |
|---|---|---|---|---|
| PFDP-01 | Brown paint / Wood trim | Lower level | < 0.0072 | |

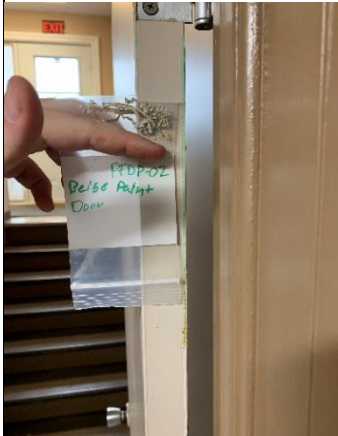
| Sample No.: | Colour / Substrate Description | Location | Lead Content (%) | Photo |
|---|---|---|---|---|
| PFDP-02 | Beige paint / Wood trim | Lower level | <0.0056 | |

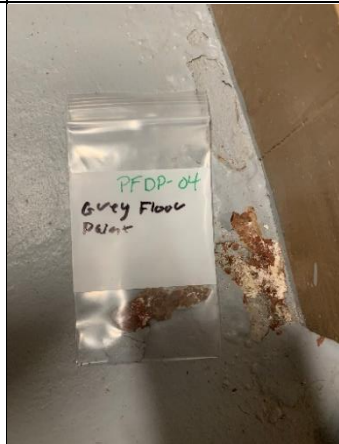
| PFDP-04 | Grey paint / Cement flooring | Boiler room | < 0.0069 | |

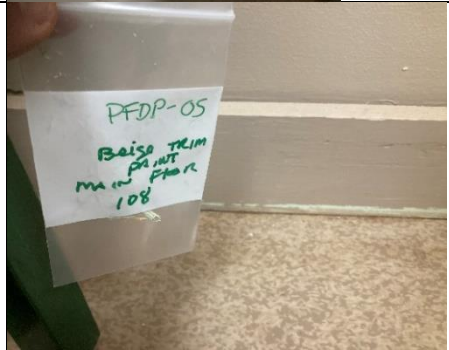
| PFDP-05 | Beige paint / Door trim | Main floor room 108 | <0.017 | |

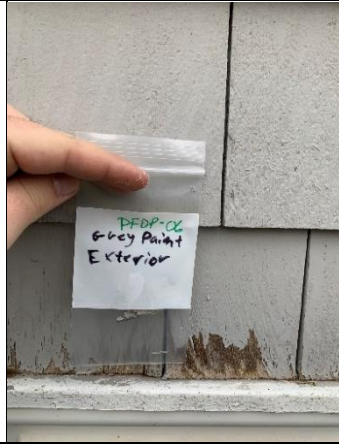
| PFDP-06 | Grey paint / Wood siding | Exterior | <0.0087 | |

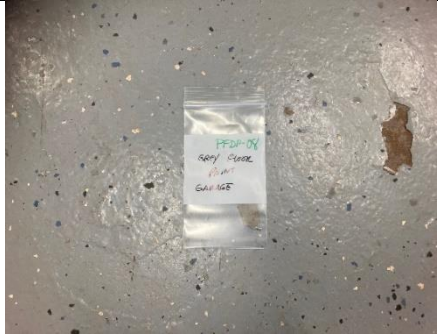
| Garage | | | | |
|---|---|---|---|--|
| PFDP-08 | Grey paint /<br>Floor | Garage | <0.0075 | |

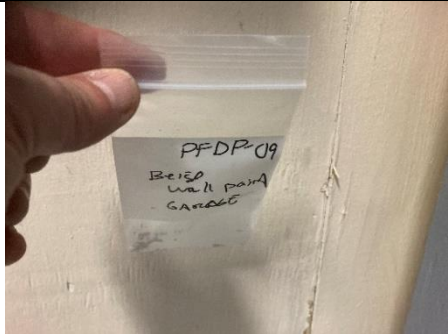
| Garage | | | | |
|---|---|---|---|--|
| PFDP-09 | Beige paint /<br>Wood siding | Garage | <0.0068 | |

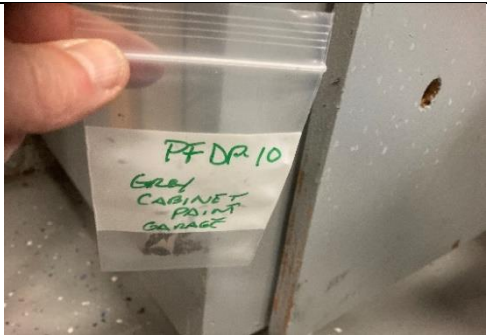
| Garage | | | | |
|---|---|---|---|--|
| PFDP-10 | Grey paint /<br>Wood cabinet | Garage | < 0.0068 | |

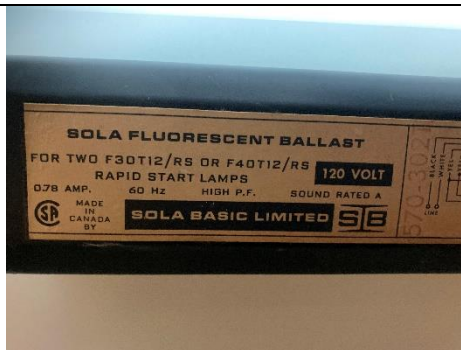
Photo 1 – SOLA Basic Limited Fluorescent Lamp Ballasts – Serial No.: 570-302T. Through referencing, these ballasts are considered **PCB containing**.

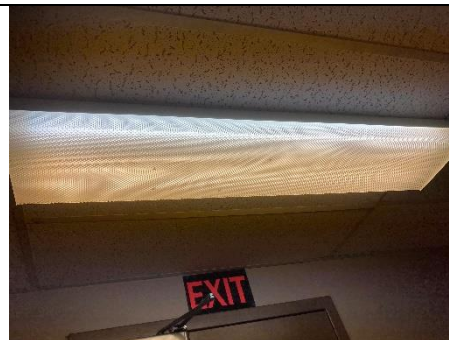
Photo 2 – Typical recessed light fixtures for these ballasts.

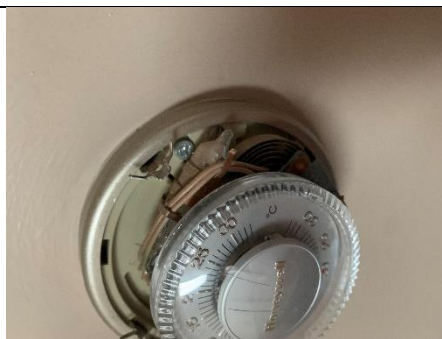
Mercury containing thermostats were observed within the building on the lower and upper floors.

Do not break lamps or separate liquid mercury from components. Recycle and reclaim mercury from fluorescent lamps and thermostats when taken out of service. Mercury is classified as a hazardous waste and must be disposed of in accordance with applicable regulations.

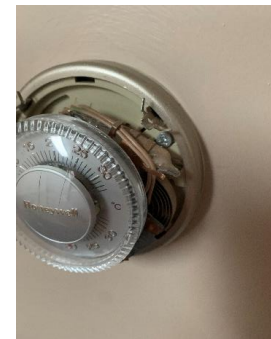
| Material | Comments | Photo |
|---|---|--|
| Mercury filled thermostats | all like thermostats considered mercury filled. | |
