# **HAZARDOUS MATERIALS ASSESSMENT**

## **Summerside Youth Centre**

### **159 Greenwood Drive, Summerside, PE**

**ALL-TECH Project No.: PE22400**

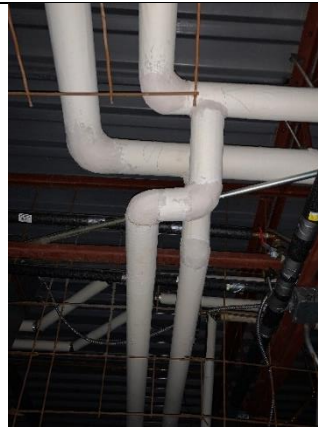
Pipe elbows above ceiling tiles.

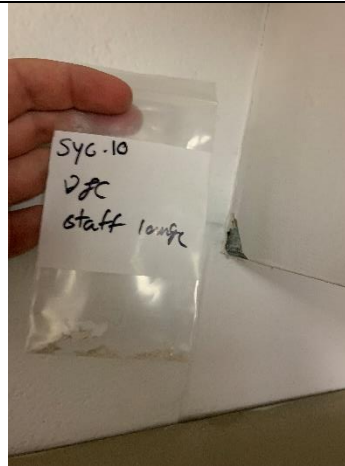
Sample: SYC-10

A total of twenty-two (22) joint compound samples were collected during the assessment. None of the samples were found to be asbestos containing.

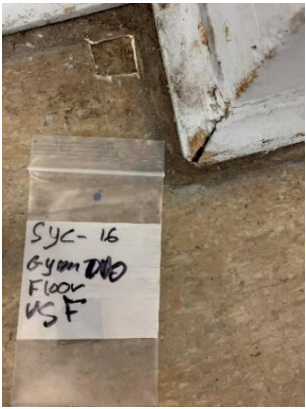
SYC-16	Tan vinyl sheet flooring	<b>Main Bldg.</b> Gymnasium	None Detected

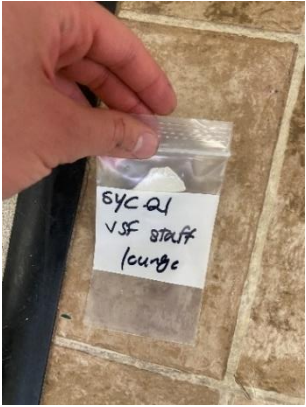
SYC-21	Grey vinyl sheet flooring	<b>Main Bldg.</b> Staff Lounge	None Detected

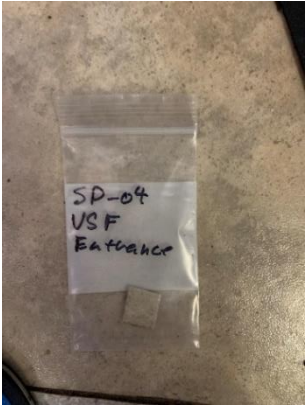
SYC-24	Off-White vinyl sheet flooring	<b>Main Bldg.</b> Kitchen	None Detected	N/A
SP-04	Off-White vinyl sheet flooring with yellow mastic	<b>Strength Program</b> Room 001	None Detected in all phases

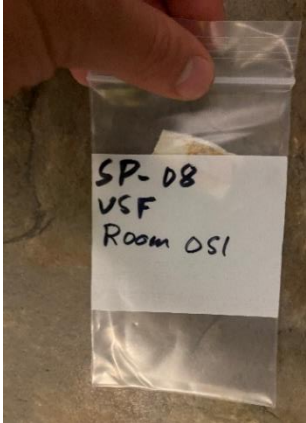
SP-08	Grey vinyl sheet flooring with yellow mastic	<b>Strength Program</b> Room 051	None Detected in all phases

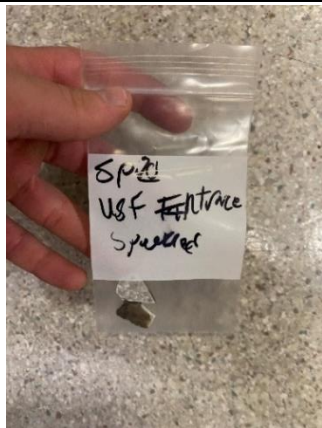
SP-20	Grey speckled vinyl sheet flooring with yellow mastic	<b>Strength Program</b> Room 001	None Detected in all phases

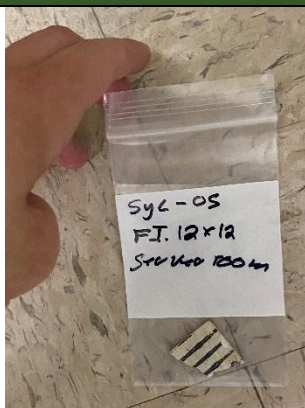
Sample No.:	Flooring Description	Building / Location	Asbestos Type / Content (%)	Photo
SYC-05 SYC-08 SYC-09 SYC-25	12" x 12" tan floor tile with black mastic	<b>Main Bldg.</b> Room A08; A29; Dining area	None Detected in tile or mastic

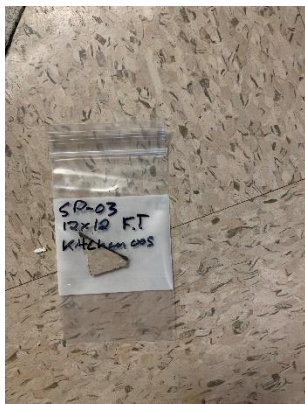
SP-03	12" x 12" beige floor tile with black mastic and levelling compound	<b>Strength Program</b> Kitchen R-005	None Detected in all phases

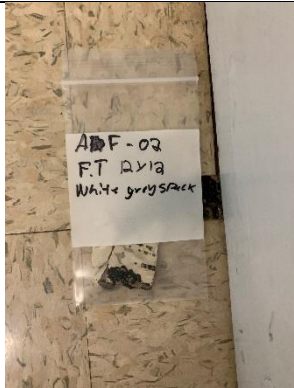
SP-09	12" x 12" grey floor tile with black mastic	<b>Strength Program</b> Meeting room 023	None Detected in all phases	 
AF-02	12" x 12" beige floor tile with black mastic	<b>Adult Female Bldg.</b> Room 154	None Detected in all phases

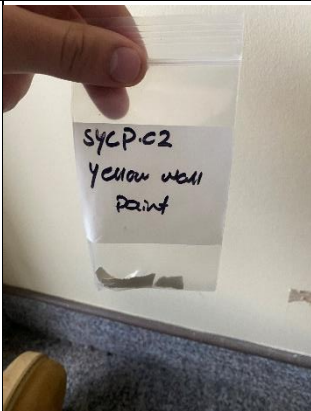
Sample No.:	Colour / Substrate Description	Location	Lead Content (%)	Photo
<b>Main Building</b>				
SYCP-02	Yellow paint / Wall surface	Room A03	< 0.0082

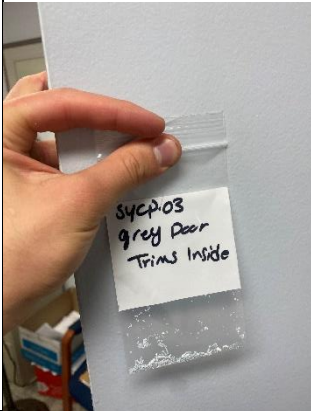
SYCP-03	Grey paint / Door trim	Room A06	< 0.020

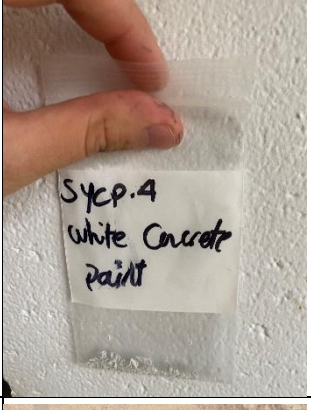
SYCP-04	White paint / Concrete walls	Room A15	< 0.017

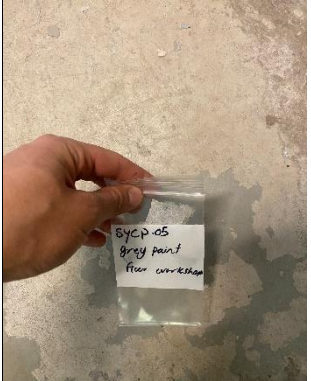
SYCP-05	Grey paint / Concrete floor	Workshop	0.042

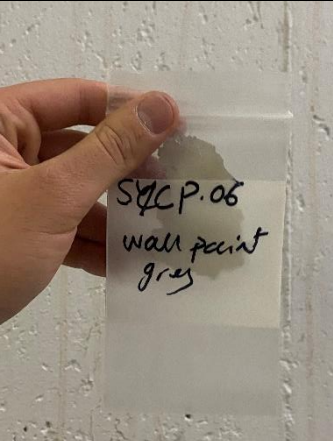
SYCP-06	Grey paint / Concrete wall	Workshop	< 0.076

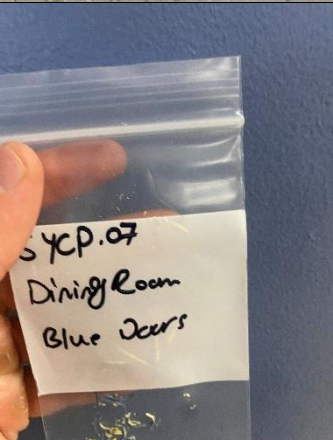
SYCP-07	Blue paint / Door	Dining Room	< 0.019

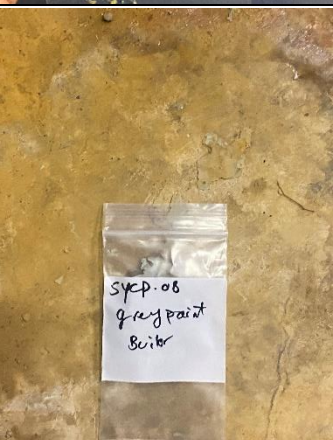
SYCP-08	Grey paint / Concrete floor	Boiler room	0.058

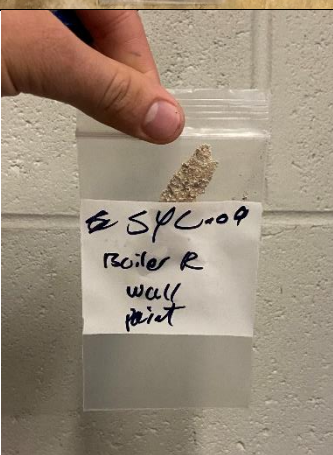
SYCP-09	Off-white paint / Concrete wall	Boiler room	< 0.0079

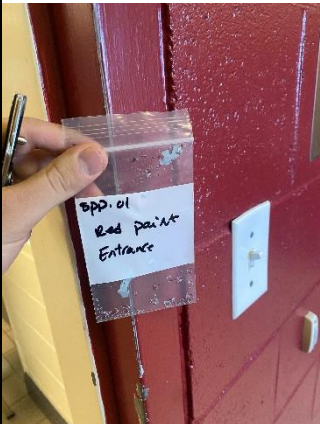
SPP-01	Red paint / Concrete / wood wall	Entrance	0.031

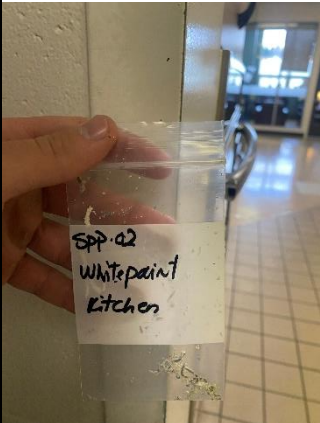
SPP-02	White paint / Concrete wall	Kitchen	< 0.0096

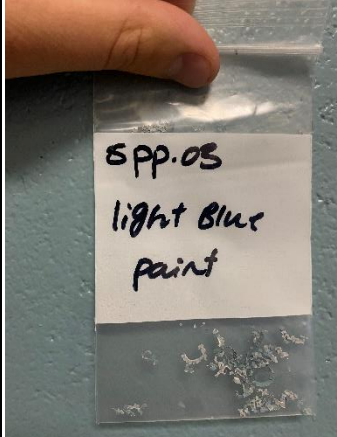
SPP-03	Light blue paint / Concrete wall	Main area	0.035

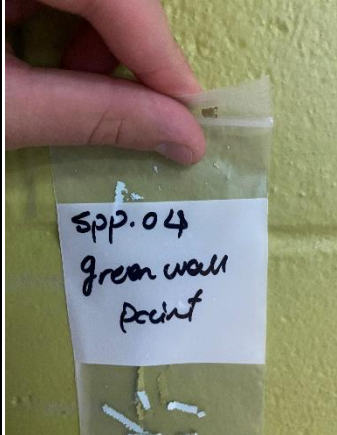
SPP-04	Green paint / Concrete wall	Main area	< 0.0088

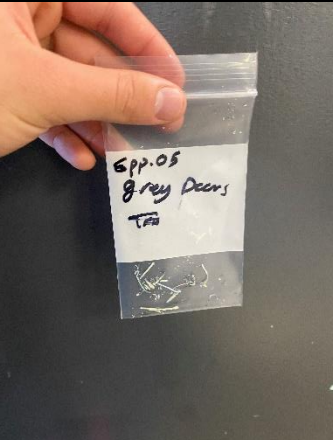
SPP-05	Grey paint / Door	Main area	< 0.011

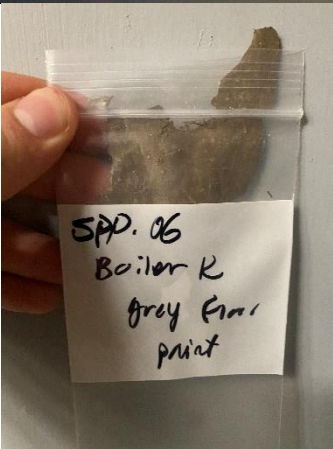
Based on the assessment findings, two (2) of the paint layers sampled exceeded CEPA guidelines of 0.06 percent by weight for surface coating materials. Exceedances are noted in bold red in the table below.

SPP-06	Grey paint / Concrete floor	Boiler room	0.18

Dispose of painted materials exceeding the criteria for leachable lead as hazardous waste.

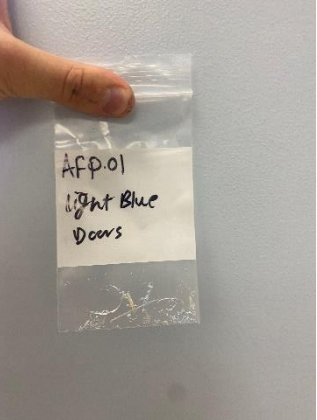
<b>Adult Female Building</b>				
AFP-01	Light blue paint / Door	Main area	<0.017

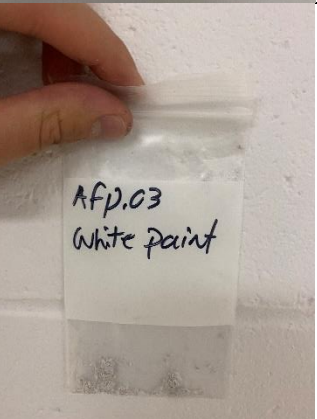
AFP-03	White paint / Concrete wall	Main area	<0.0085

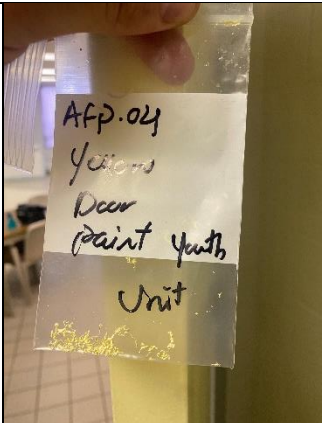
AFP-04	Yellow paint / Door	Youth unit	<0.018

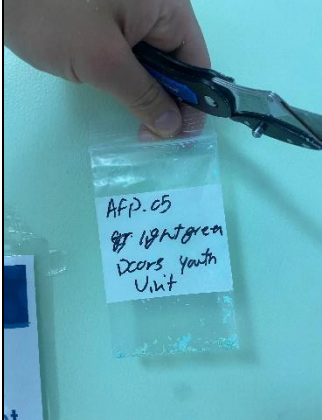
AFP-05	Light green paint / Door	Youth unit	<0.0093

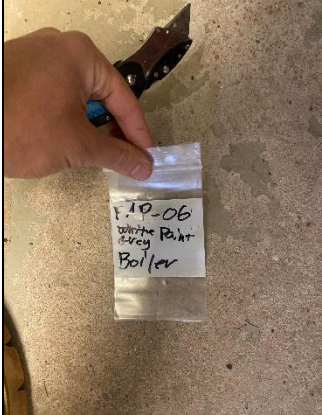
AFP-06	Grey paint / Concrete floor	Boiler room	0.14
