HAZARDOUS MATERIALS ASSESSMENT

Tyne Valley Youth Centre, 61 Bideford Road, Tyne Valley , PE

March 28, 2023

ALL-TECH Project No.: PE22400

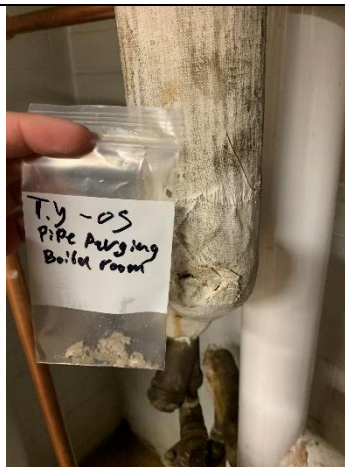
Pipe parging cement is present on pipe fittings as identified through various samples within the boiler room. A total of three (3) parging cement samples were collected and none were found to contain asbestos.

Parging cement on pipe fittings

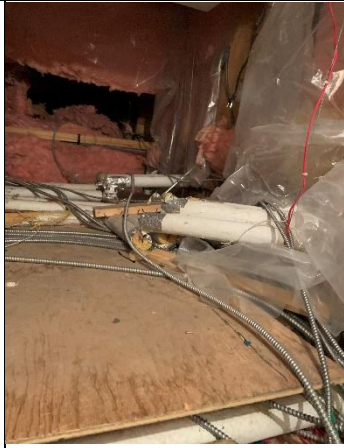
Fiber Glass insulation above ceiling in boiler room.

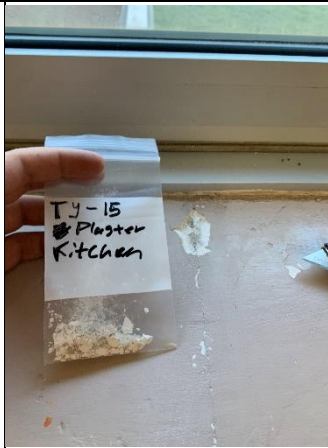
A total of five (5) plaster finishes were collected during the assessment. None were found to be asbestos containing.

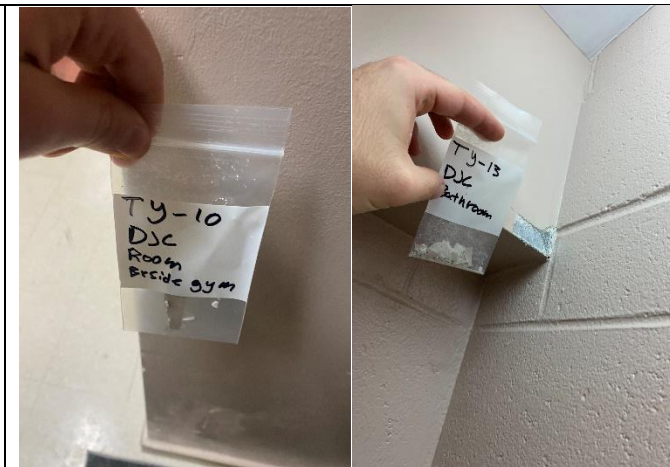
A total of five (5) joint compound samples were collected during the assessment. None were found to be asbestos containing.

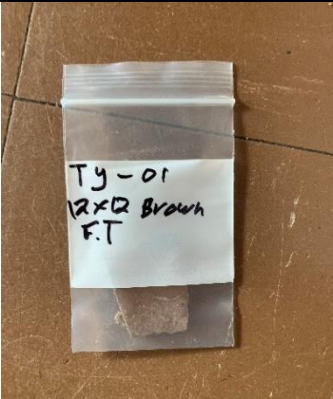
Sample No.:	Flooring Description	Location	Asbestos Type / Content (%)	Photo
TY-01	12"x12" Brown floor tile with black mastic	Common Areas	None Detected in tile or mastic

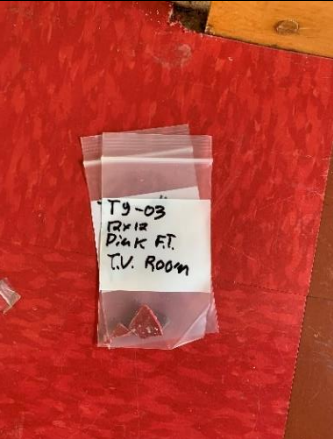
TY-02	12"x12" Yellow speckled floor tile	Office	None Detected	 
TY-03	12"x12" Pink floor tile	TV Room	None Detected

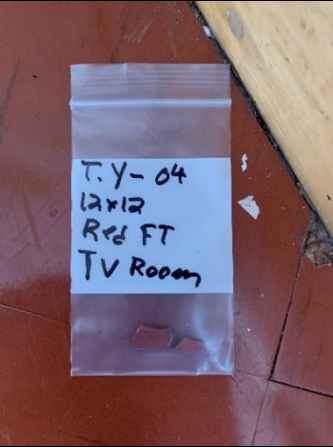
TY-04	12"x12" Red floor tile	TV room	None Detected

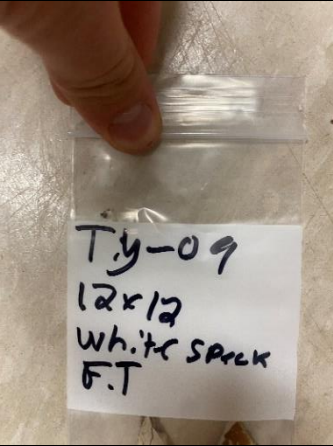
TY-09	12"x12" White speckled floor tile with tan mastic	Common area	None Detected in tile or mastic

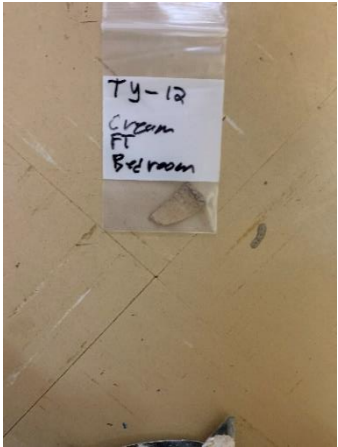
TY-12	12"x12" Cream floor tile with black mastic	Bedroom	None Detected in tile or mastic

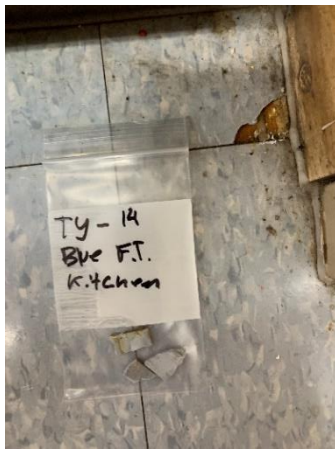
TY-14	12"x12" Blue floor tile	Kitchen	None Detected

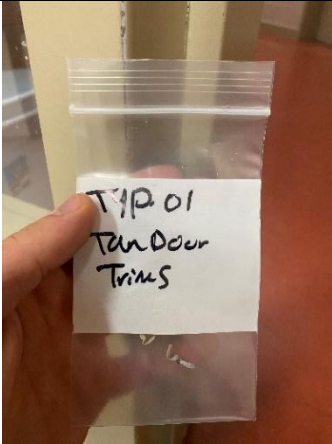
Sample No.:	Colour / Substrate Description	Location	Lead Content (%)	Photo
TYP-01	Tan paint / Wood door trim	Main Entrance	0.010

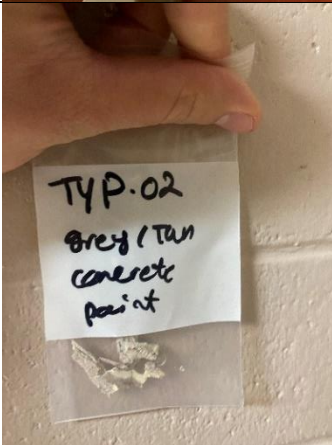
TYP-02	Grey paint / Concrete wall	Open areas	0.0066

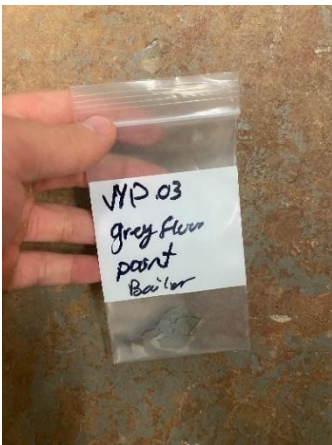
Based on the assessment findings, one (1) of the paint layers sampled exceeded CEPA guidelines of 0.06 percent by weight for surface coating materials. Exceedances are noted in bold red in table below.

TYP-03	Grey paint / Concrete floor	Boiler Room	0.078

For lead-containing or lead-based paints (i.e., greater than the CEPA guidelines of 600 mg/kg (0.06 percent by weight) for surface coating materials, work procedures, engineering controls and personal protective equipment should be assessed on a site-specific basis to comply with Occupational Health and Safety regulations and Lead guidelines.

Dispose of painted materials exceeding the criteria for leachable lead as hazardous waste.

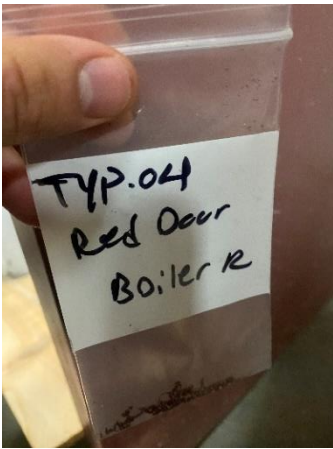
TYP-04	Red Paint / Door	Boiler Room	0.020
