**P.E.I.
Public Forests**

Woodlot Management Plan

Property Numbers: 219212, 219204 & 804245

Location: Riverdale

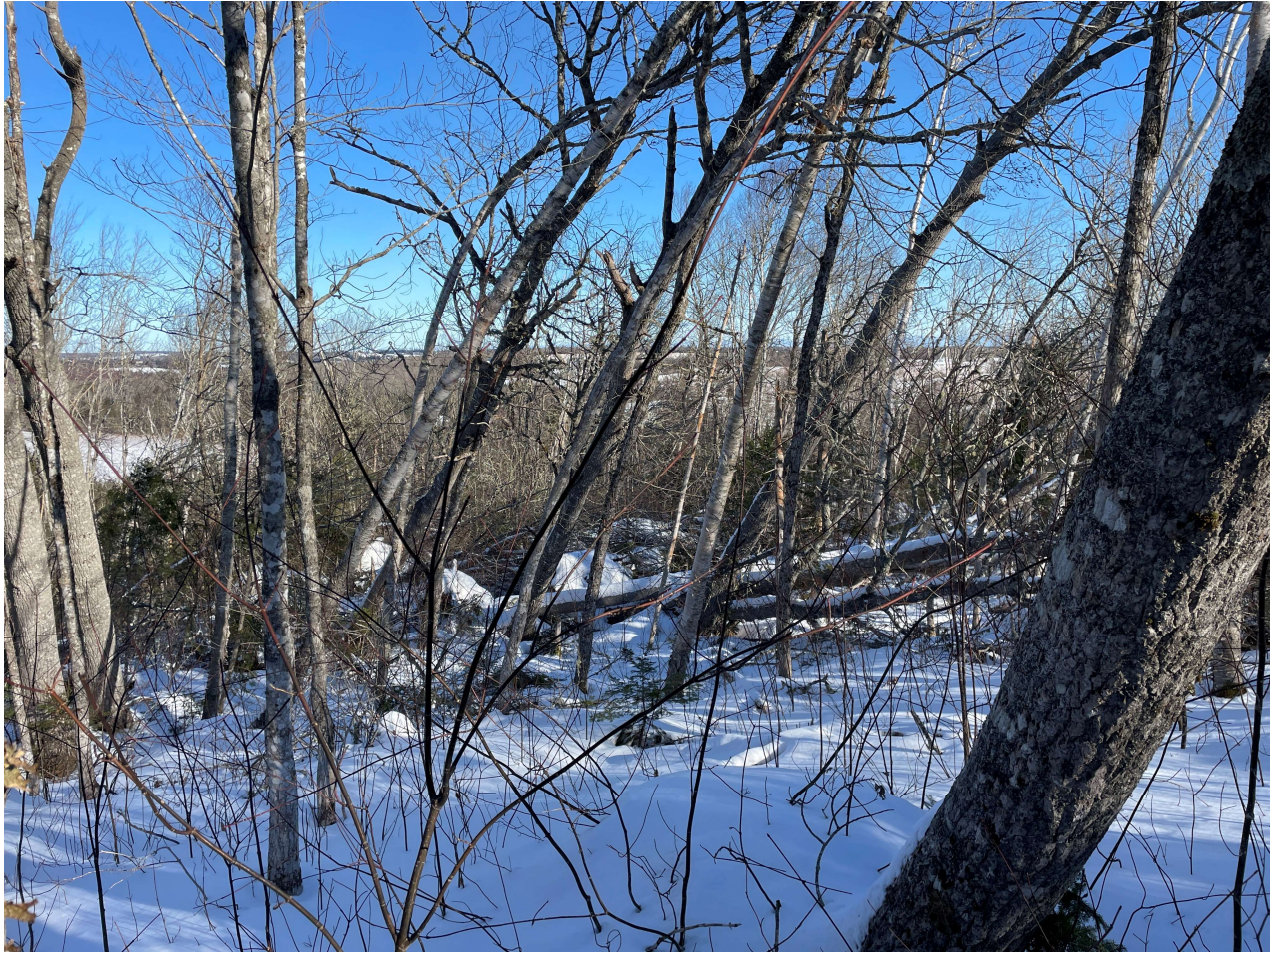
Mature hardwoods at higher elevation on a north facing slope wind damaged by hurricane Fiona in stand# 951415.

951415	Patch Harvest	2023	0.40 Ha	Pg 29	Fiona windfall, road edges, leaning trees	Improve road safety, some Fionasalvage if adjacent
951415	*Patch Harvest (overall generally no treatment)	2023	0.20 Ha	Pg 29	Fiona windfall, road edges, leaning trees	Improve road safety, some Fionasalvage if adjacent
951298 PN#4740017	Block Harvest/ Patch Harvest (modified)	2023	0.90 Ha	Pg 30&29	90% Fiona windfall, snags	Salvage timber (limit fire fuel load)
951297	Patch Harvest	2023	0.60 Ha	Pg 29	Red Maple, could patch harvest for fuelwood	Create openings for quality regeneration or leave
951248, 951247 PN#4760025	Block Harvest/ Patch Harvest (modified)	2023	2.90 Ha	Pg 30&29	90% Fiona windfall, snags	Salvage timber (limit fire fuel load)
951297	Patch Harvest	2023	1.00 Ha	Pg 29	5% Fiona windfall, older RM, low priority	Could create small openings to encourage quality regeneration or leave
951250 PN#2943043	Block Harvest/ Commercial Thin	2023	3.0 Ha	Pg 30&26	Immature W/P (north and east 70% Fiona windfall, southeast 30%)	Block salvage, selective salvage, leave healthy and quality stems

Shelterwood Cut				Selection Cut				Patch Cut		X		Strip Cut	
Commercial Thinning				Afforestation				Site Preparation					
Pre-commercial Thinning				Reforestation				Riparian Zone Mgmt					
Pln. Maint.		Y / N		Stems/Ha									
Comments:		younger patch around 37 years to east, rest is mature hardwood stand (SM content), typical older											
		hardwood stand, some Fiona hurricane windfall onto road, minimal log quality in SM stems, stable											
		hardwood stand with exposed slope to north, salvage windfall to clear road surface and edge of road											
		to allow access by select salvage (save all stable stems), leave stand to develop further naturally

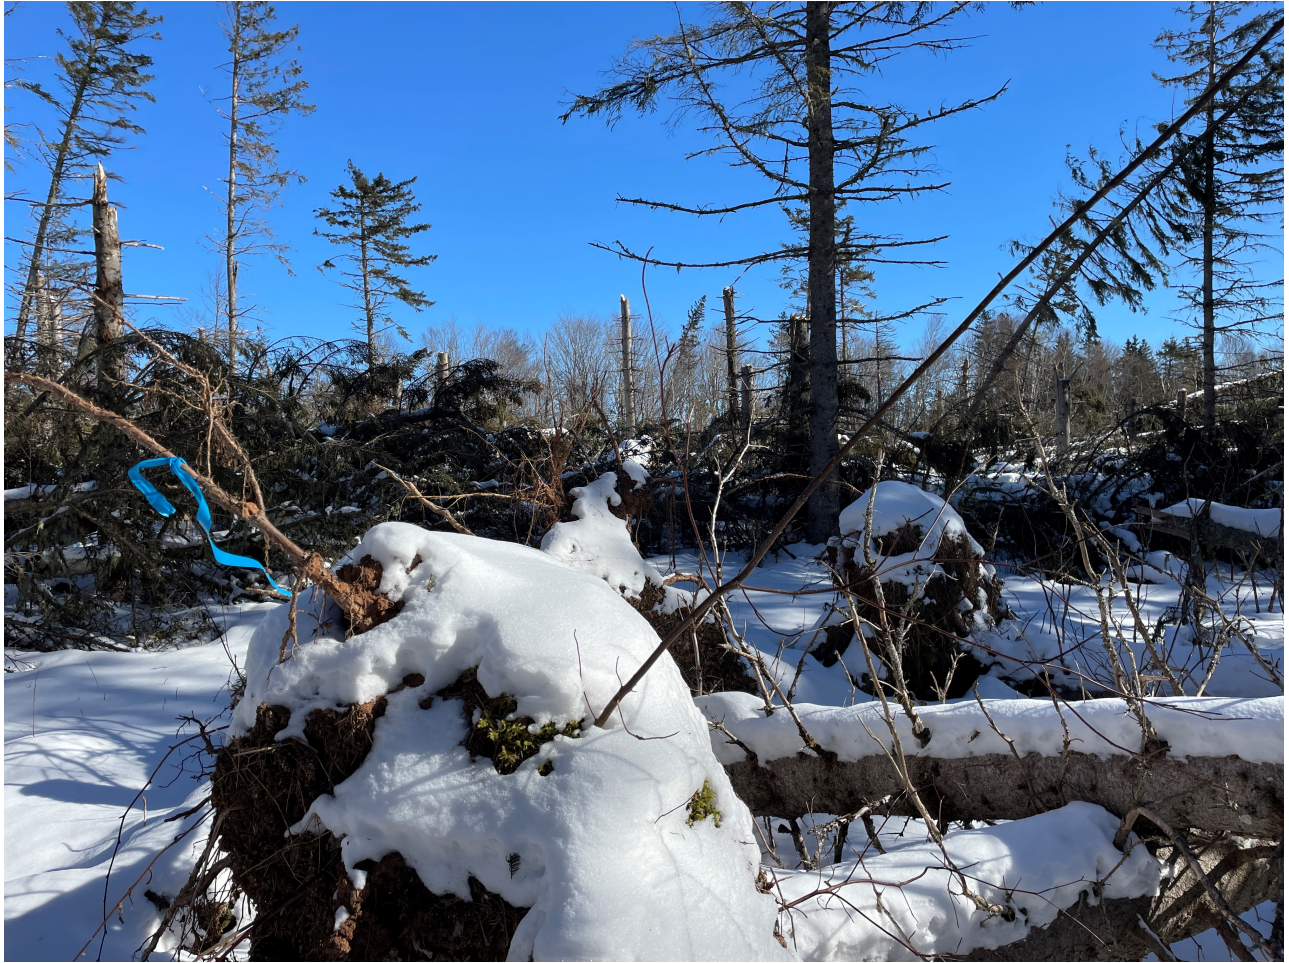
White Spruce wind-felled by hurricane Fiona in stands 951248 & 951247.

Shelterwood Cut				Selection Cut		Patch Cut		Strip Cut								
Commercial Thinning				Afforestation		Site Preparation	X									
Pre-commercial Thinning				Reforestation	X	Riparian Zone Mgmt										
Pln. Maint.		X	Y / N	Stems/Ha												
Comments:		tree improvement plantation, was commercially thinned, ranged from 30-50% live crown ratio,														
		relatively open grown stand at elevation, occassional SM was found in understory, some bark beetle,														
		90% of the trees were windfelled by hurricane Fiona east and 55% west(quality timber), minimal														
		regeneration present, salvage harvest and enhancement plant, future maintenance,														
		*protect edge of 951247 adjacent SM section to preserve any natural regeneration (heavy WF to east

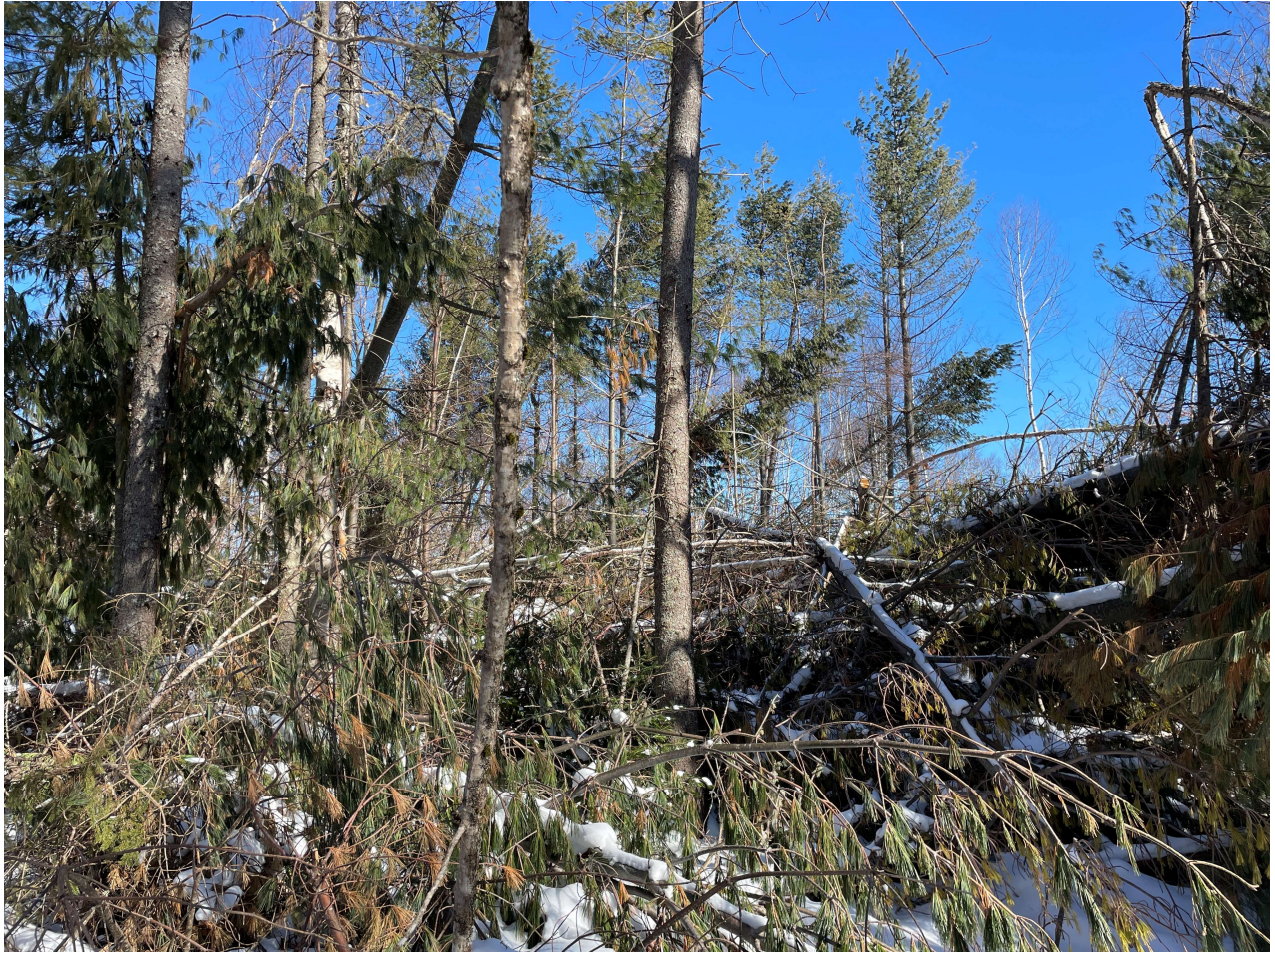
Windfall White Pine on the exposed North boundary with high elevation adjacent open agricultural land (Stand #951250).

Comments	typical WP with minimal understory (save PO for wildlife values), save any snags												
STAND PRESCRIPTION													
No Treatment				Regeneration Cut		Crop Tree Release		Block Cut	X				
Shelterwood Cut				Selection Cut	X	Patch Cut		Strip Cut					
Commercial Thinning		X		Afforestation		Site Preparation	X						
Pre-commercial Thinning				Reforestation	X	Riparian Zone Mgmt							
Pln. Maint.	X	Y / N		Stems/Ha									
Comments:	very good form planted WP, hurricane Fiona damaged heavily, on high elevation exposed to north												
	and east estimate 70% of stems windfall, south east around 20% damaged, quality WP to												
	salvage and small diameter standing WB, salvage windfall sections and selective salvage/ thin the												
	southeast with minimal damage, little white pine weevil noted (locale historically has few weevil)
