HAZARDOUS MATERIALS ASSESSMENT

Prince County Courts Building

108 Central Street, Summerside, PE

ALL-TECH Project No.: PE22400

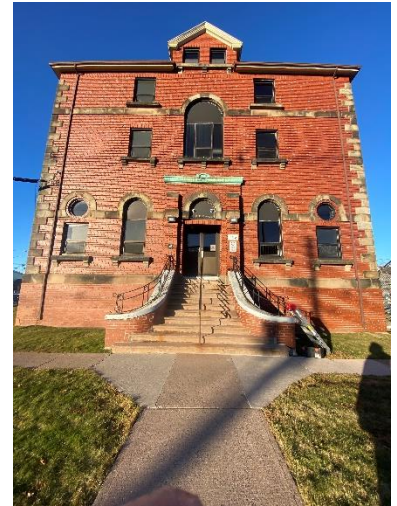
A total of forty-eight (48) bulk material samples were collected within the Court House & Jail building during the survey. Some of these samples such as flooring, plasters, and drywall joint compounds were separated and a total of seventy-nine (79) samples were analyzed. Of the 79 samples analyzed, three (3) plaster samples were found to be asbestos containing.

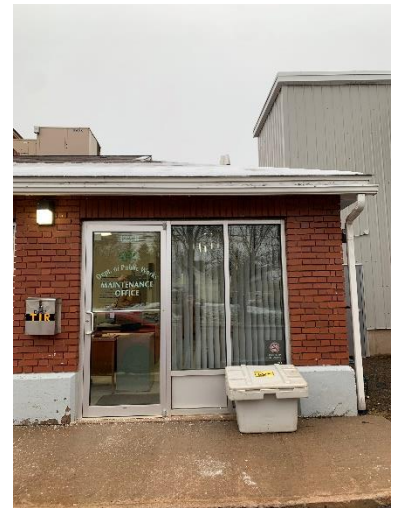
A total of ten (10) bulk material samples were collected within the Maintenance & Sheriff Offices during the survey. Some of these samples such as floor coverings and mastics were separated and a total of twelve (12) samples were analyzed. Of the 12 samples analyzed, none were found to be asbestos containing.

Other materials such as pipe and duct insulations visually identified as fiberglass insulation were noted and not sampled.

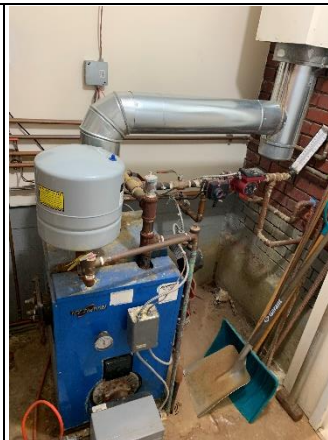
Photo 1

No mechanical pipe insulations of pipe parging was observed or reported.
