## **HAZARDOUS MATERIALS ASSESSMENT**

### **Prince County Forestry Depot**

**40 Hackmatack Rd,  
Wellington Station, PE**

**ALL-TECH Project No.: PE22400**

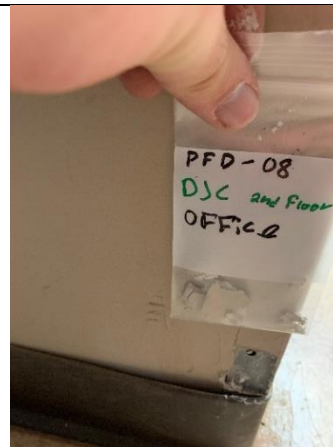
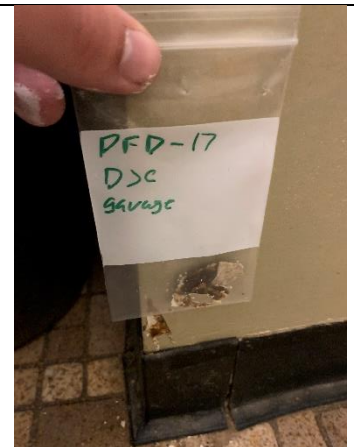
A total of six (6) joint compound samples were collected within the office building and three (3) joint compound samples collected within the garage during the assessment. None of the samples were found to contain asbestos.

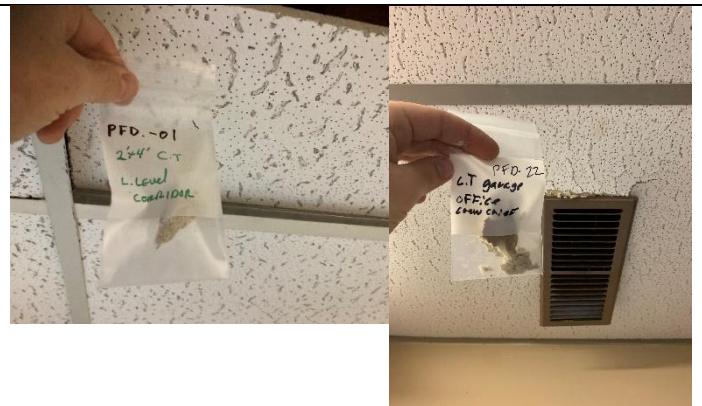
In-lay acoustic fissure ceiling tiles were observed and sampled in various random locations throughout the office and garage buildings. The ceiling tiles were observed as like materials throughout.

A total of six (6) fissure design ceiling tiles samples were collected within the office building and three samples collected within the garage during the assessment. None of the samples were found to contain asbestos.
